FY2015 Basin Highlights Report & FY2016 Coordinated Monitoring

CANADIAN AND RED RIVER BASINS ADVISORY COMMITTEE MEETING

MARCH 17, 2015 – AMARILLO, TEXAS

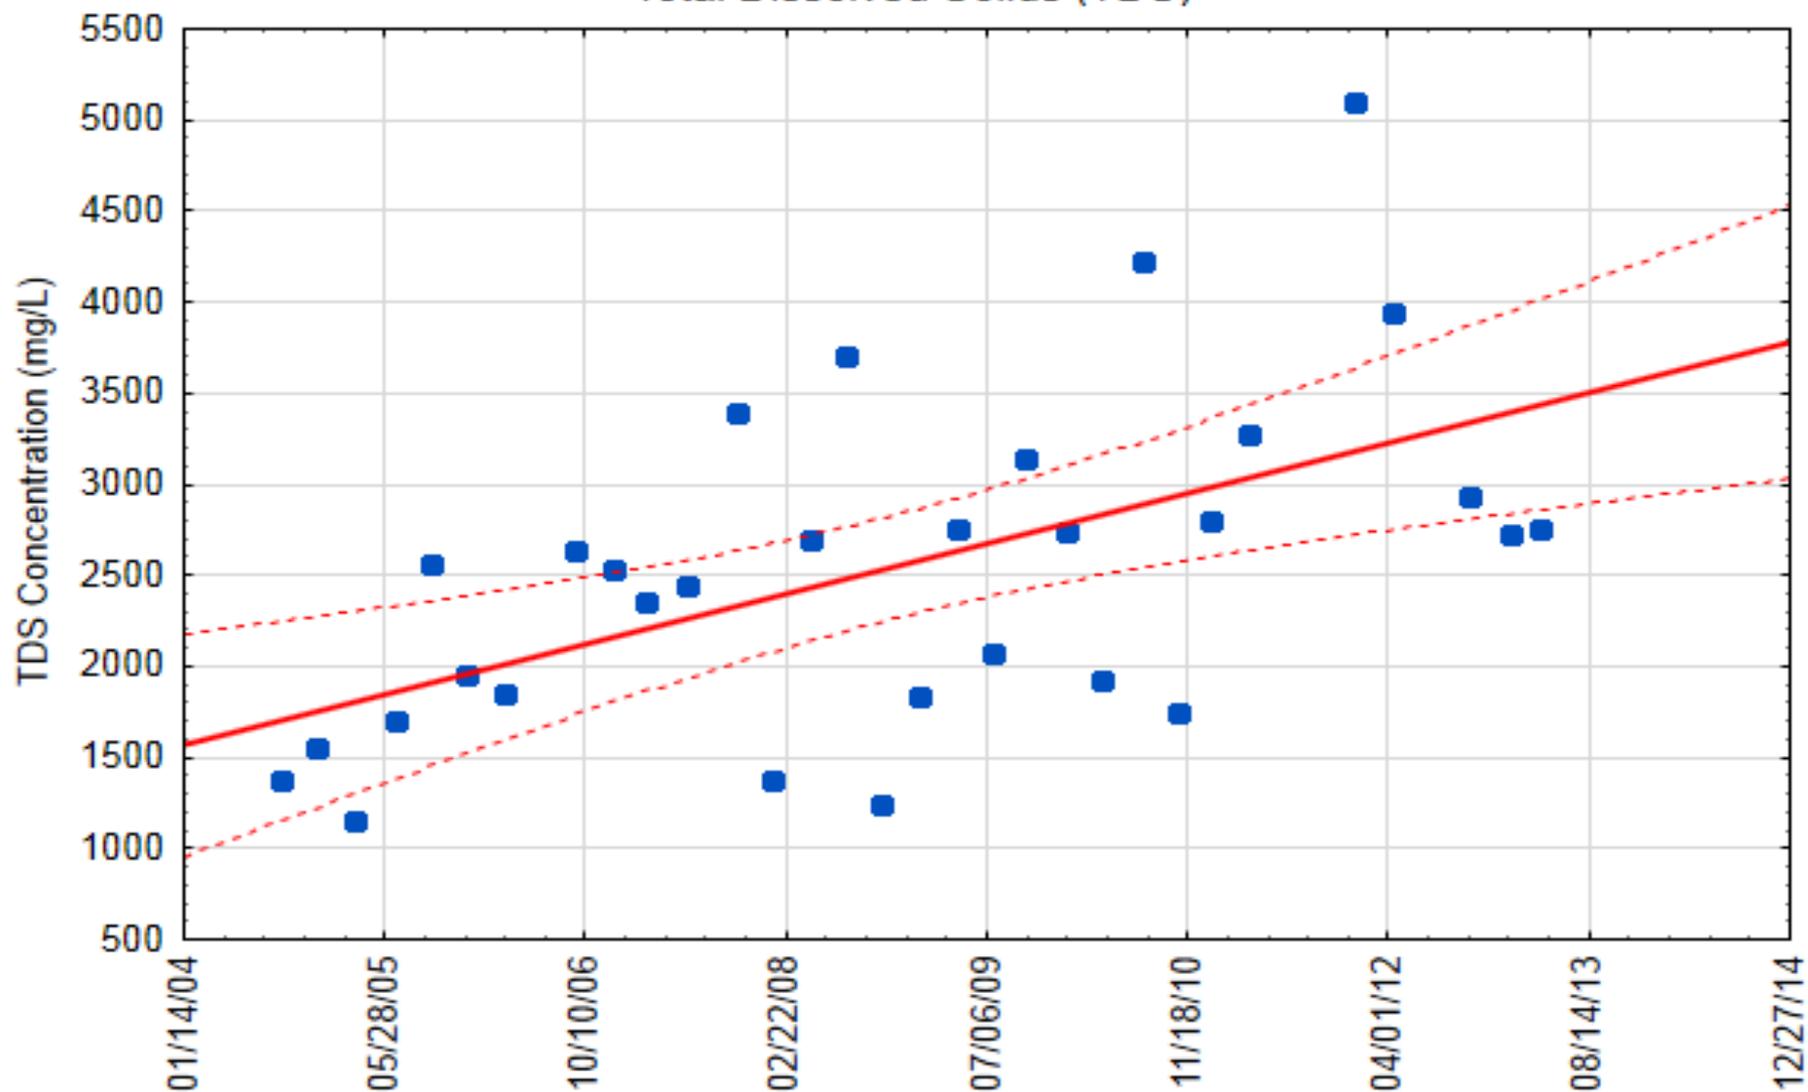
Rock Creek
Segment 0101B_01
Total Dissolved Solids (TDS)

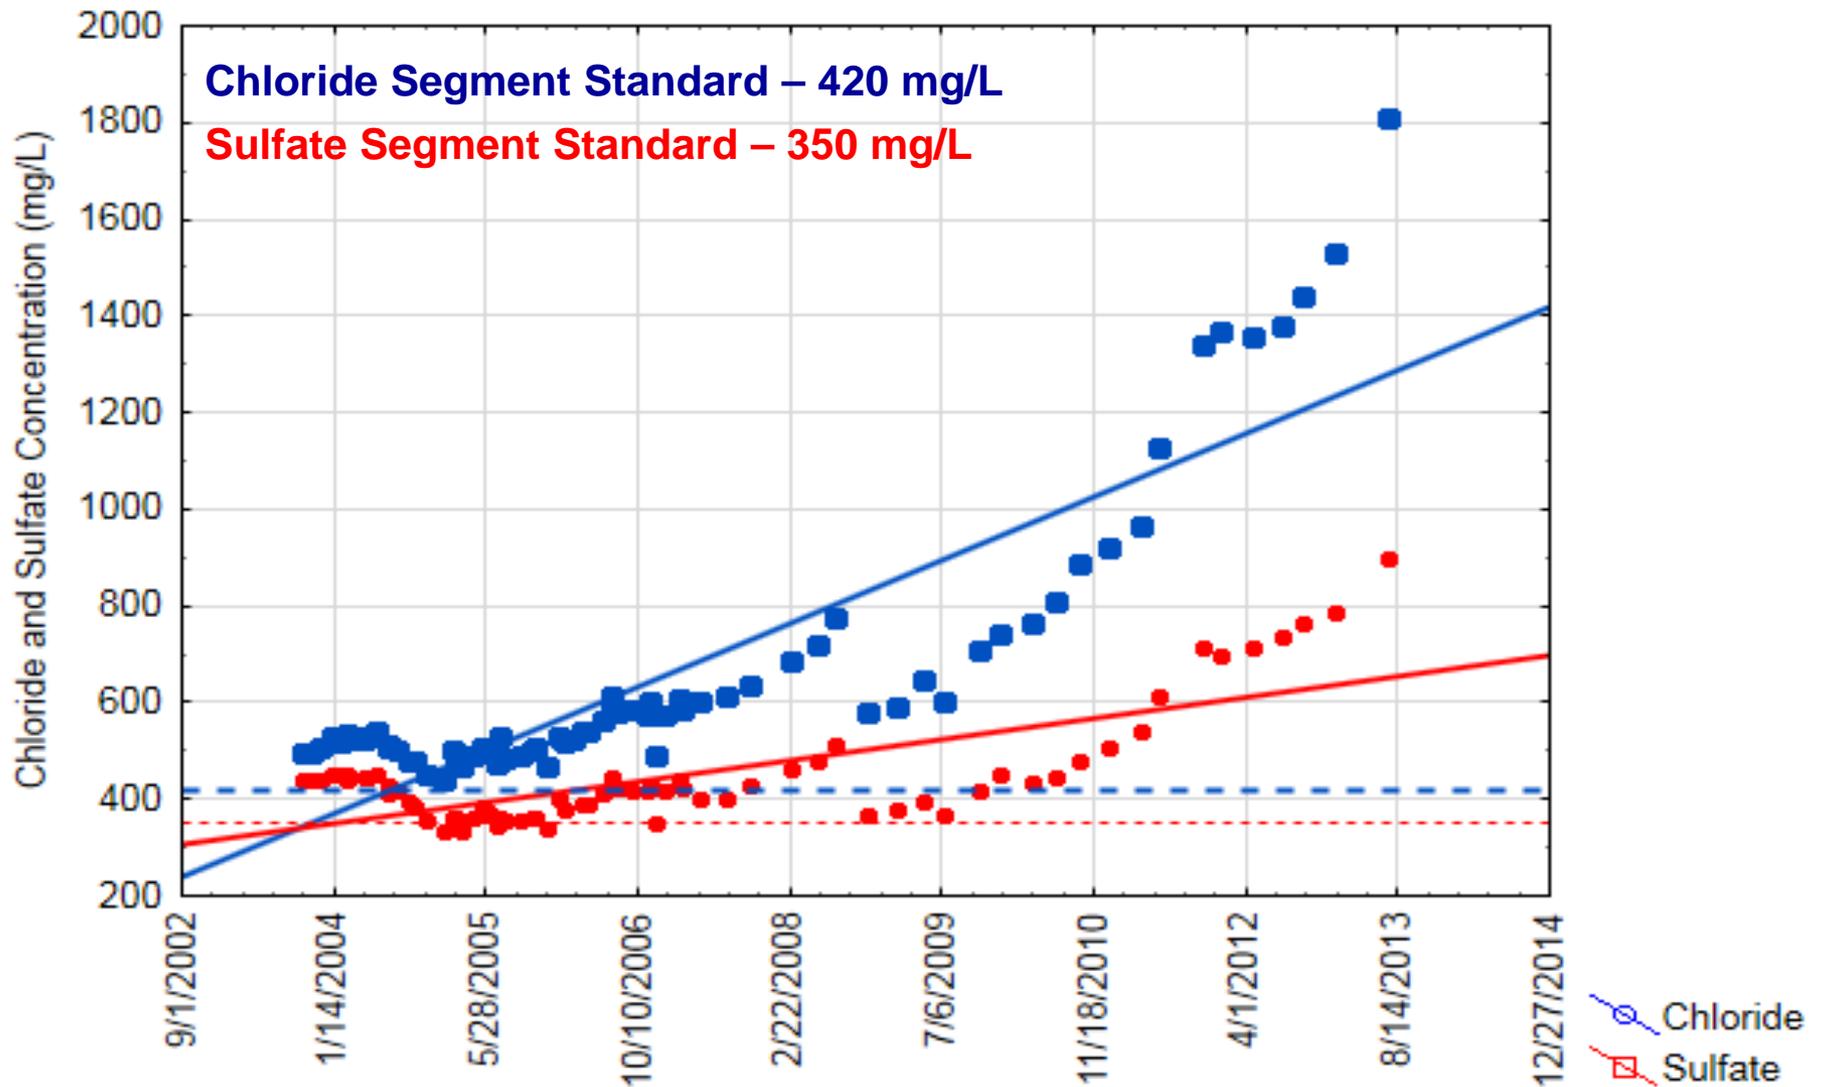
- Lake Meredith (0102)
 - Mercury in edible fish tissue, chloride, sulfate, TDS impairment
 - No concerns
- Canadian River Above Lake Meredith (0103)
- Big Blue Creek (0102A)
- East Amarillo Creek (0103A)
- Unnamed Tributary to West Amarillo Creek (0103C)

Lake Meredith
Segment 0102_01
Chloride and Sulfate

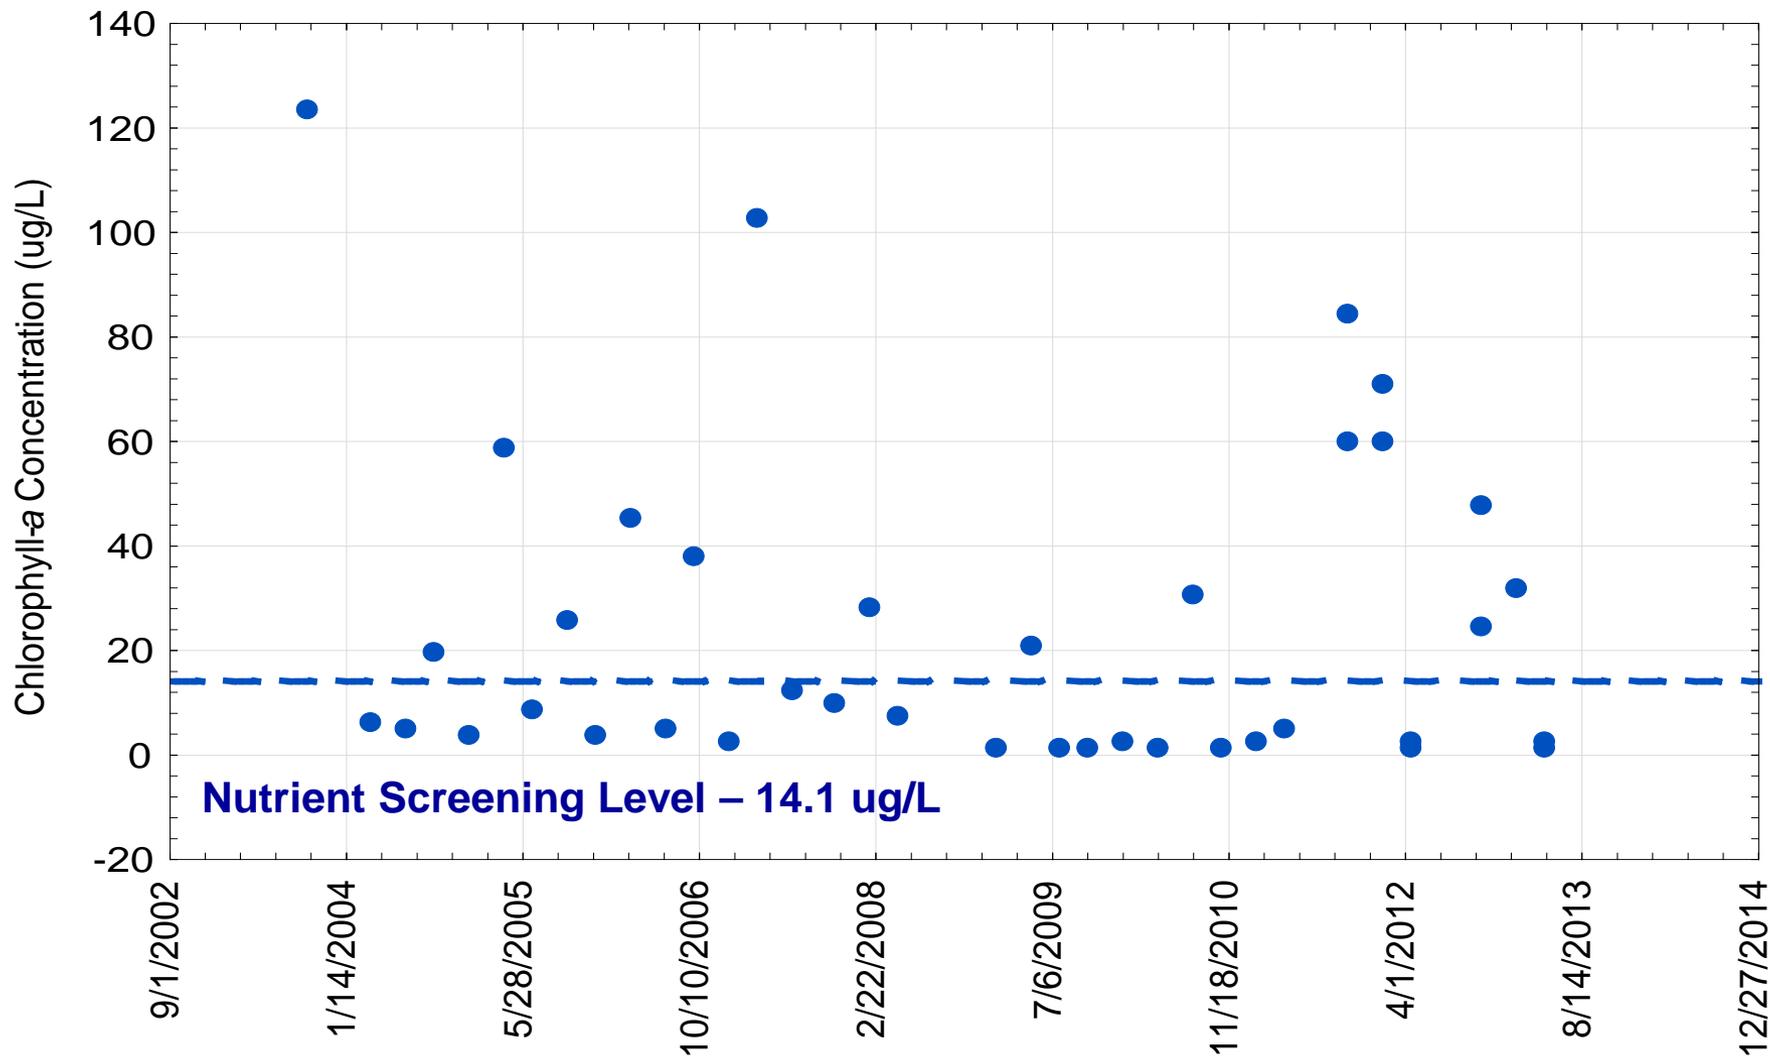
East Amarillo Creek
Segment 0103A_01
Chlorophylla

- Lake Meredith (0102)
- Big Blue Creek (0102A)
- Canadian River Above Lake Meredith (0103)
- Big Blue Creek (0102A)
- East Amarillo Creek (0103A)
 - **No impairments**
 - **Chlorophyll-*a* and nitrate concerns**
- Unnamed Tributary to West Amarillo Creek (0103C)

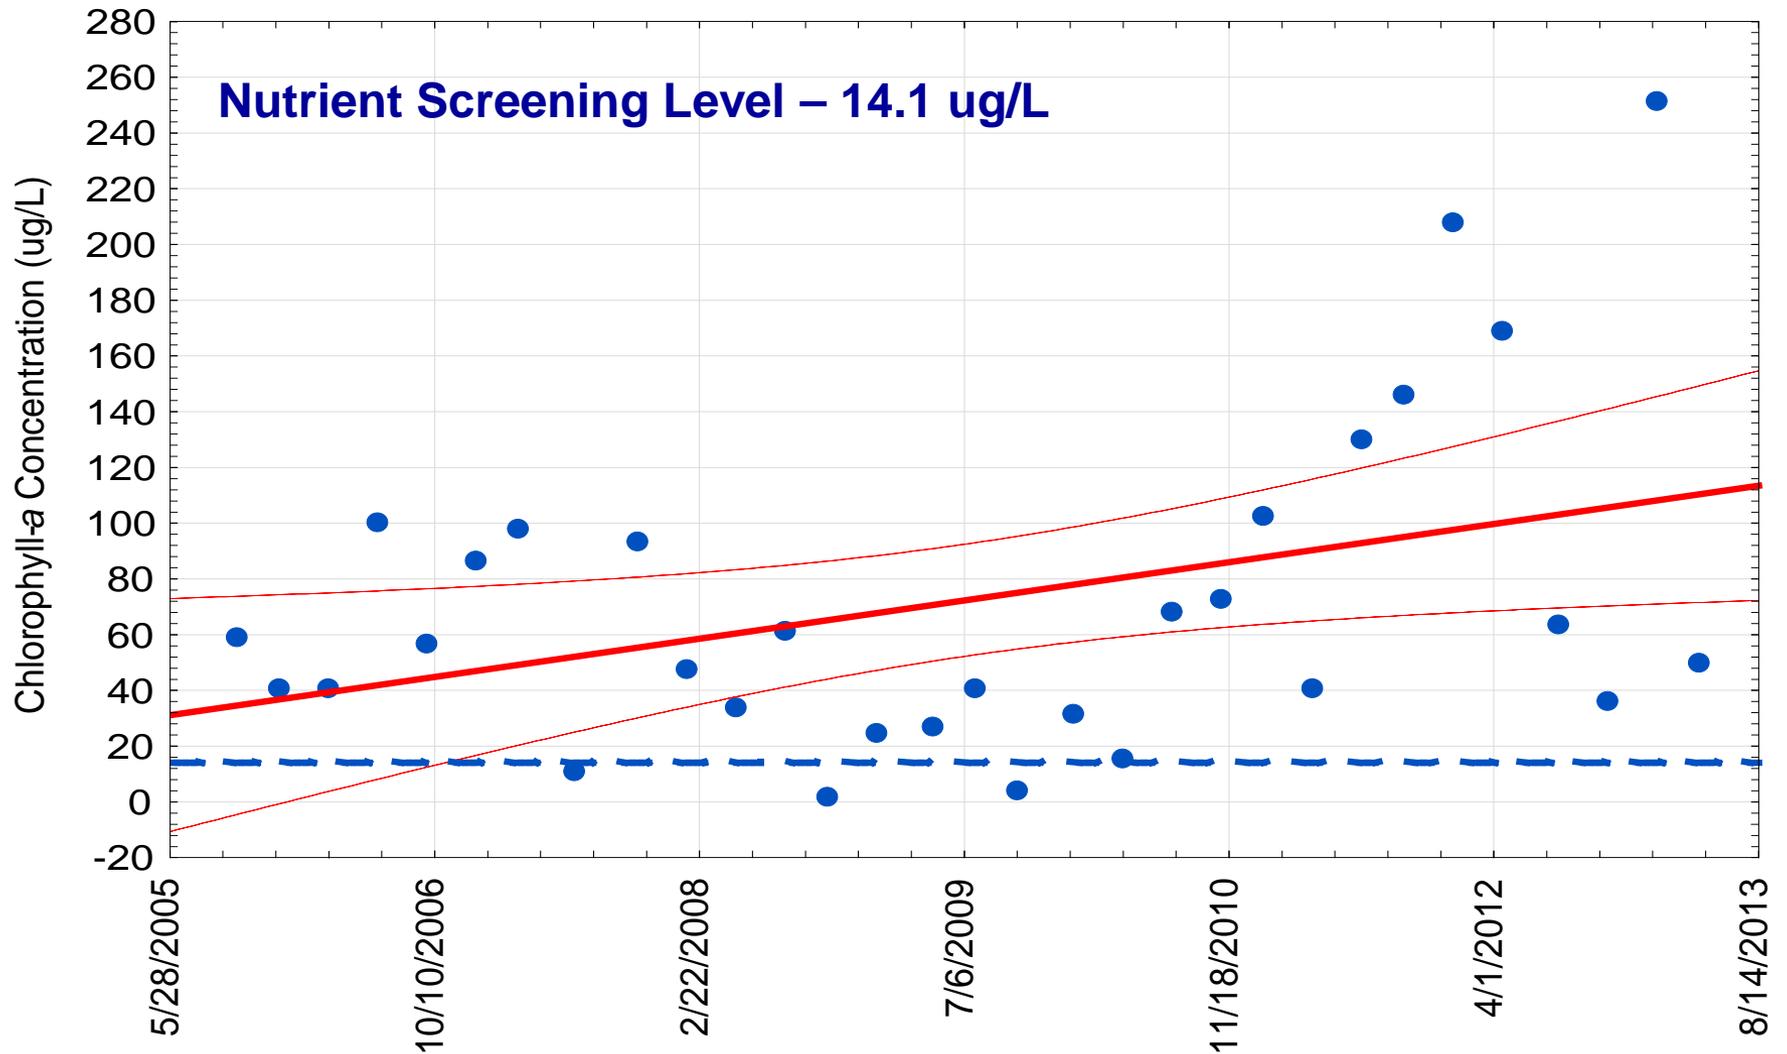
East Amarillo Creek
Segment 0103A_02
Chlorophylla

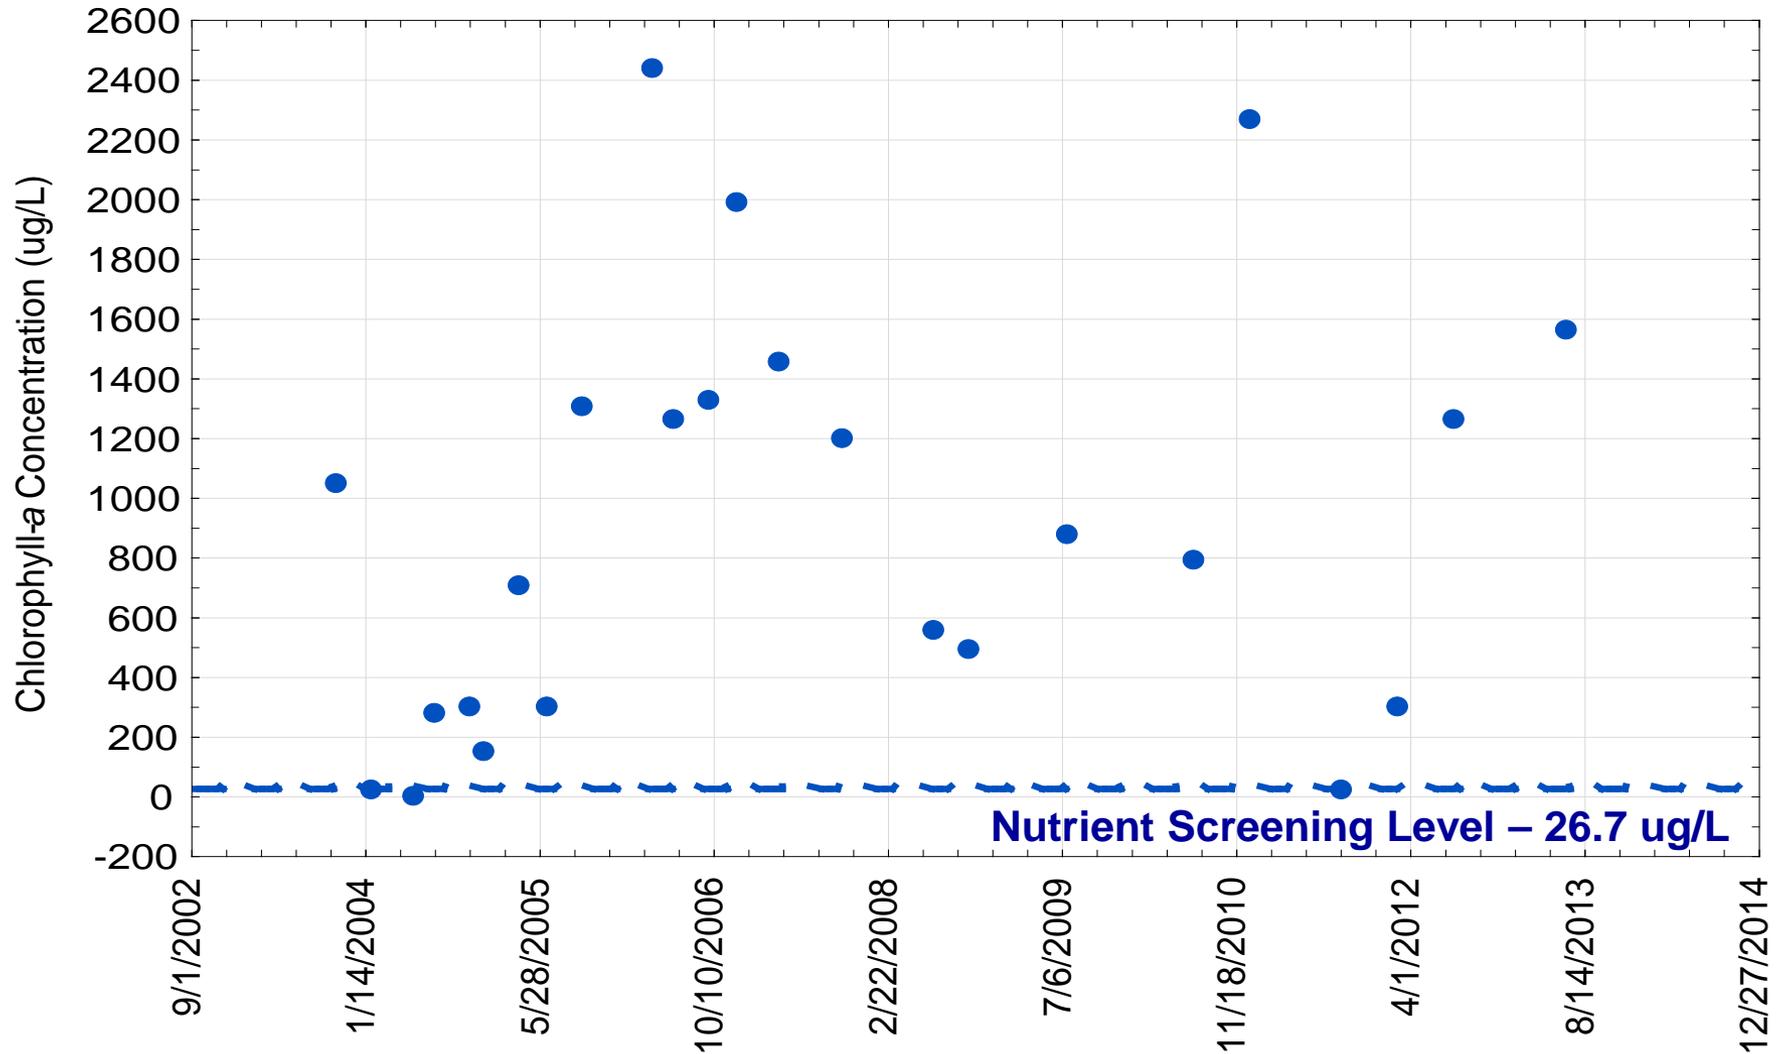
Rita Blanca Lake
Segment 0105_01
Chlorophylla

- Rita Blanca Lake (0105)
 - pH and **chloride** impairment
 - Ammonia, chlorophyll-*a*, nitrate, total phosphorus concerns

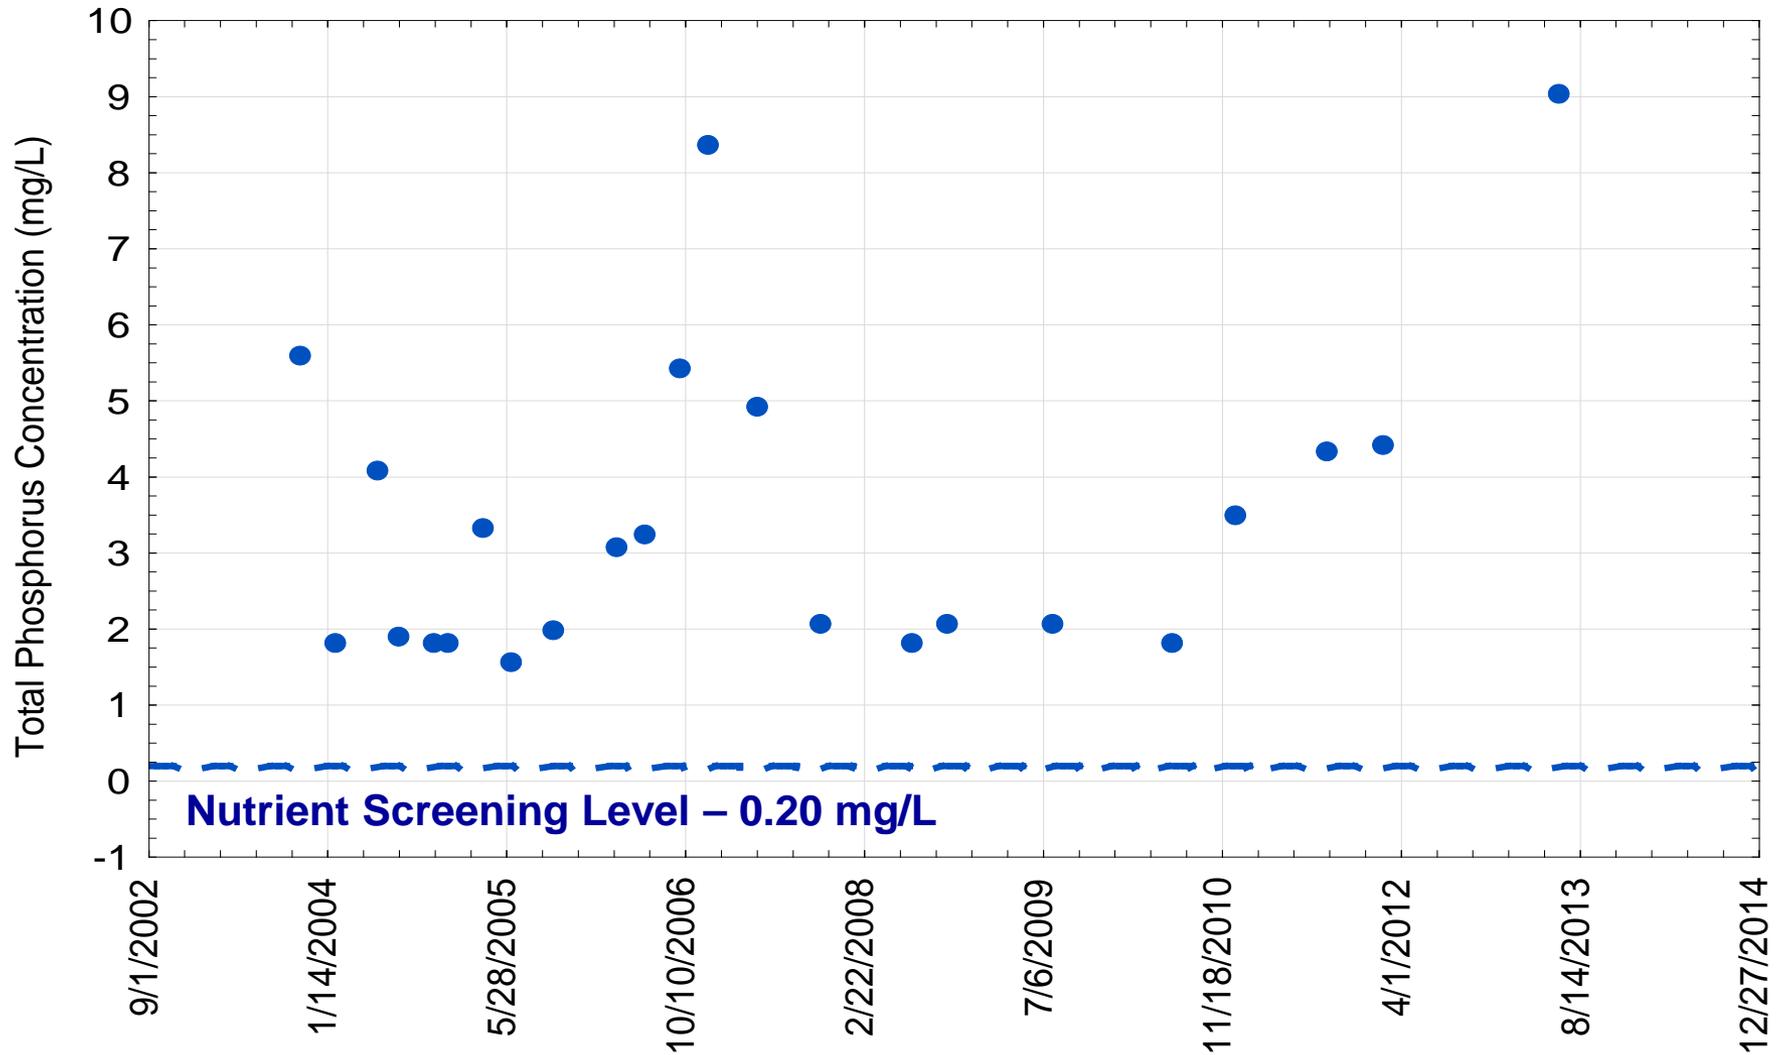
Rita Blanca Lake
Segment 0105_01
Total Phosphorus

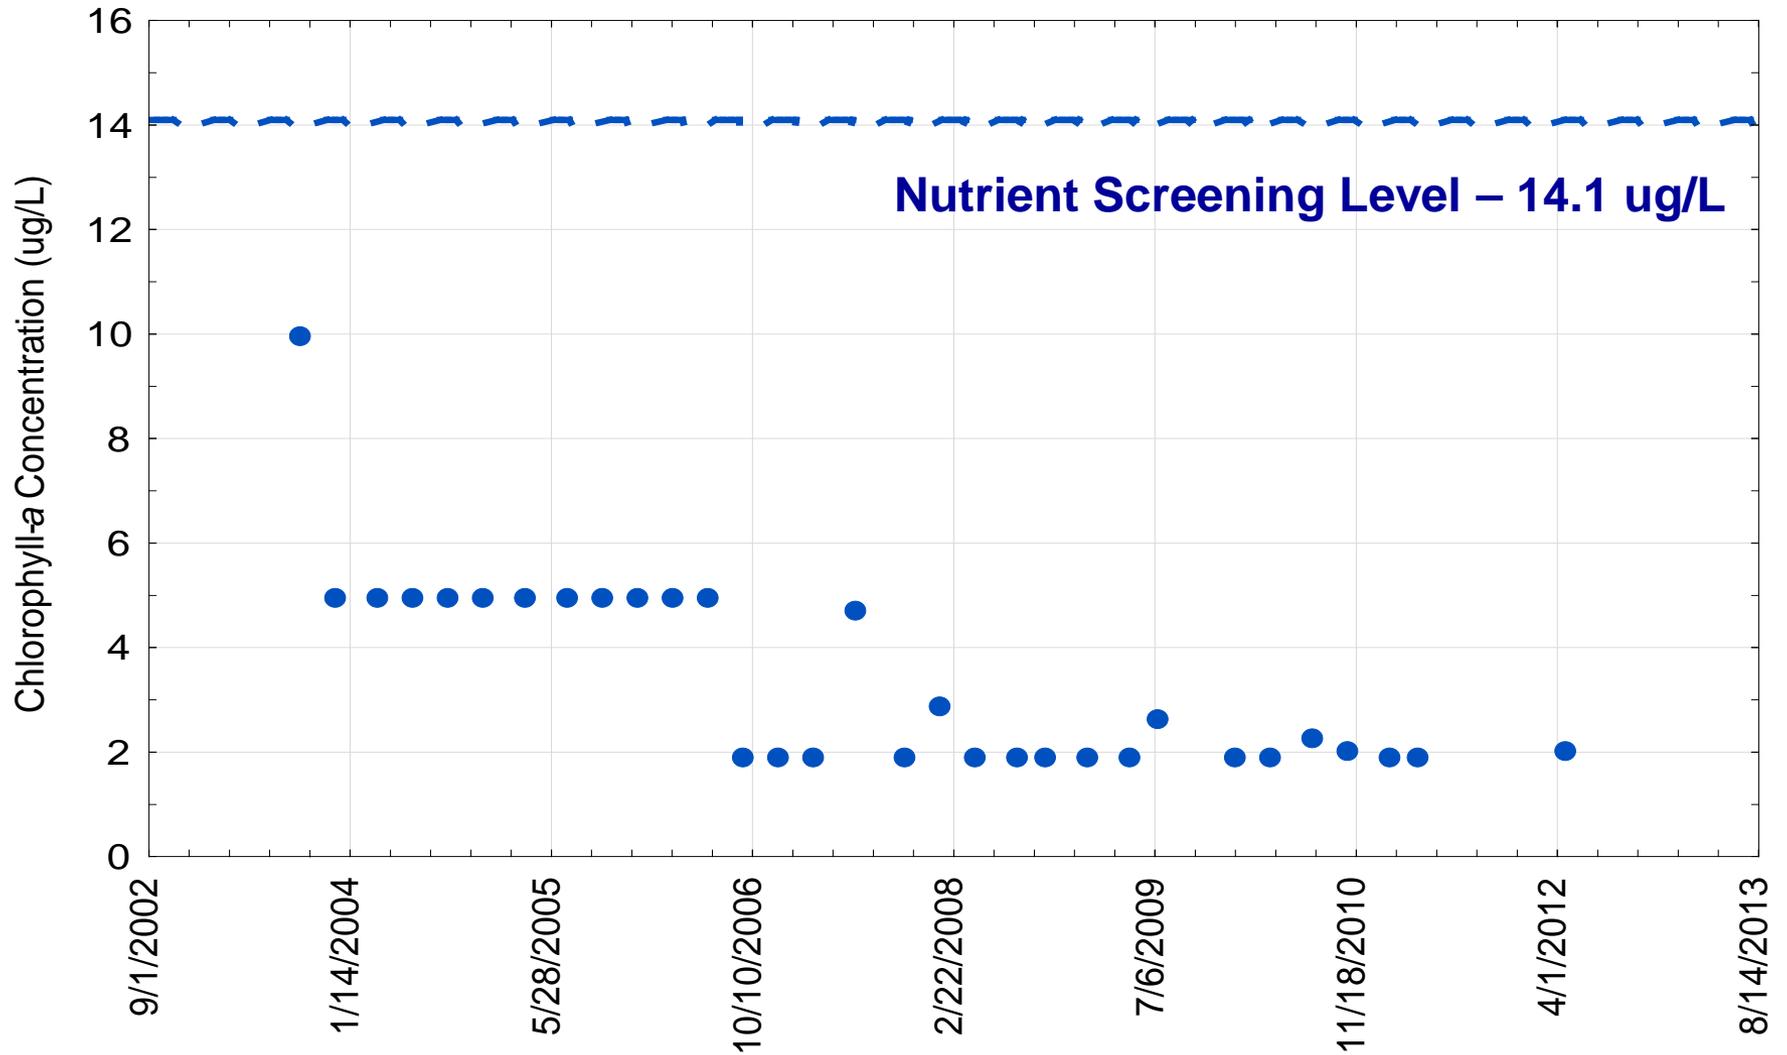
Wolf Creek at FM 1454
Segment 0104_01
Chlorophylla

- **Wolf Creek (0104)**
 - **No impairments**
 - **Chlorophyll-a concern**
- **Kiowa Creek (0199B)**

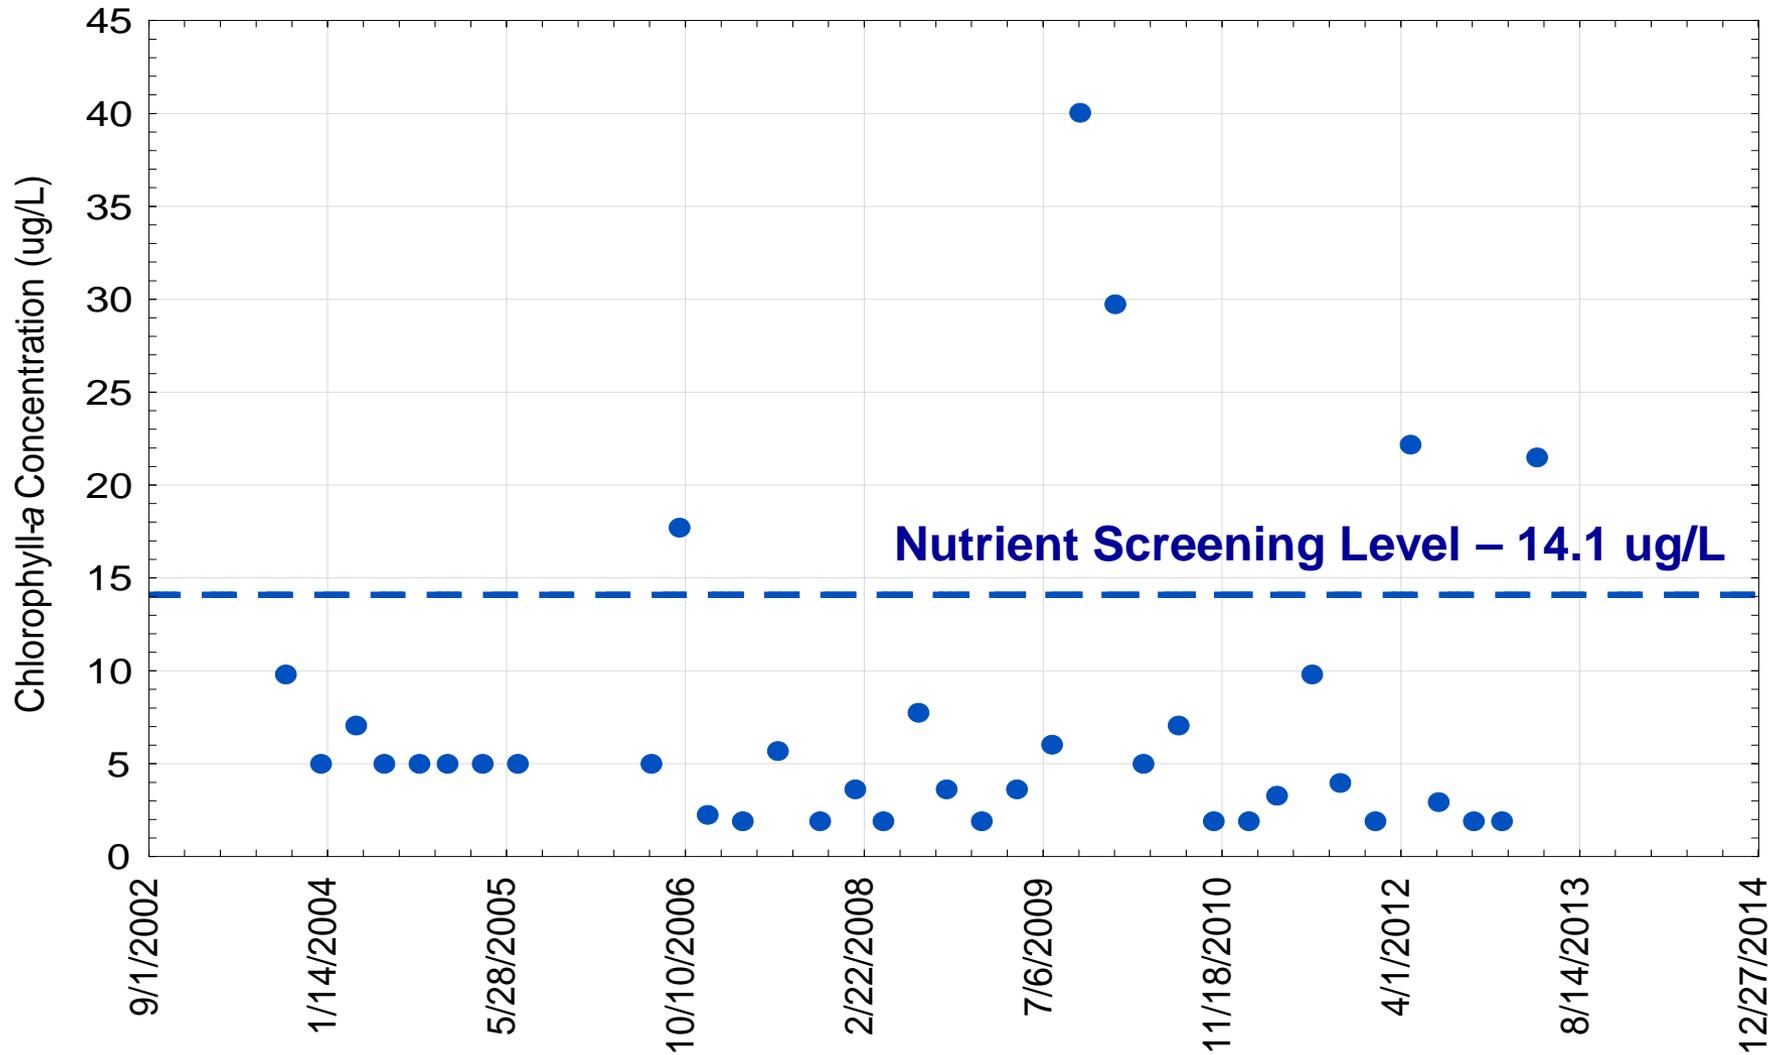
Wolf Creek at SH 305
Segment 0104_02
Chlorophylla

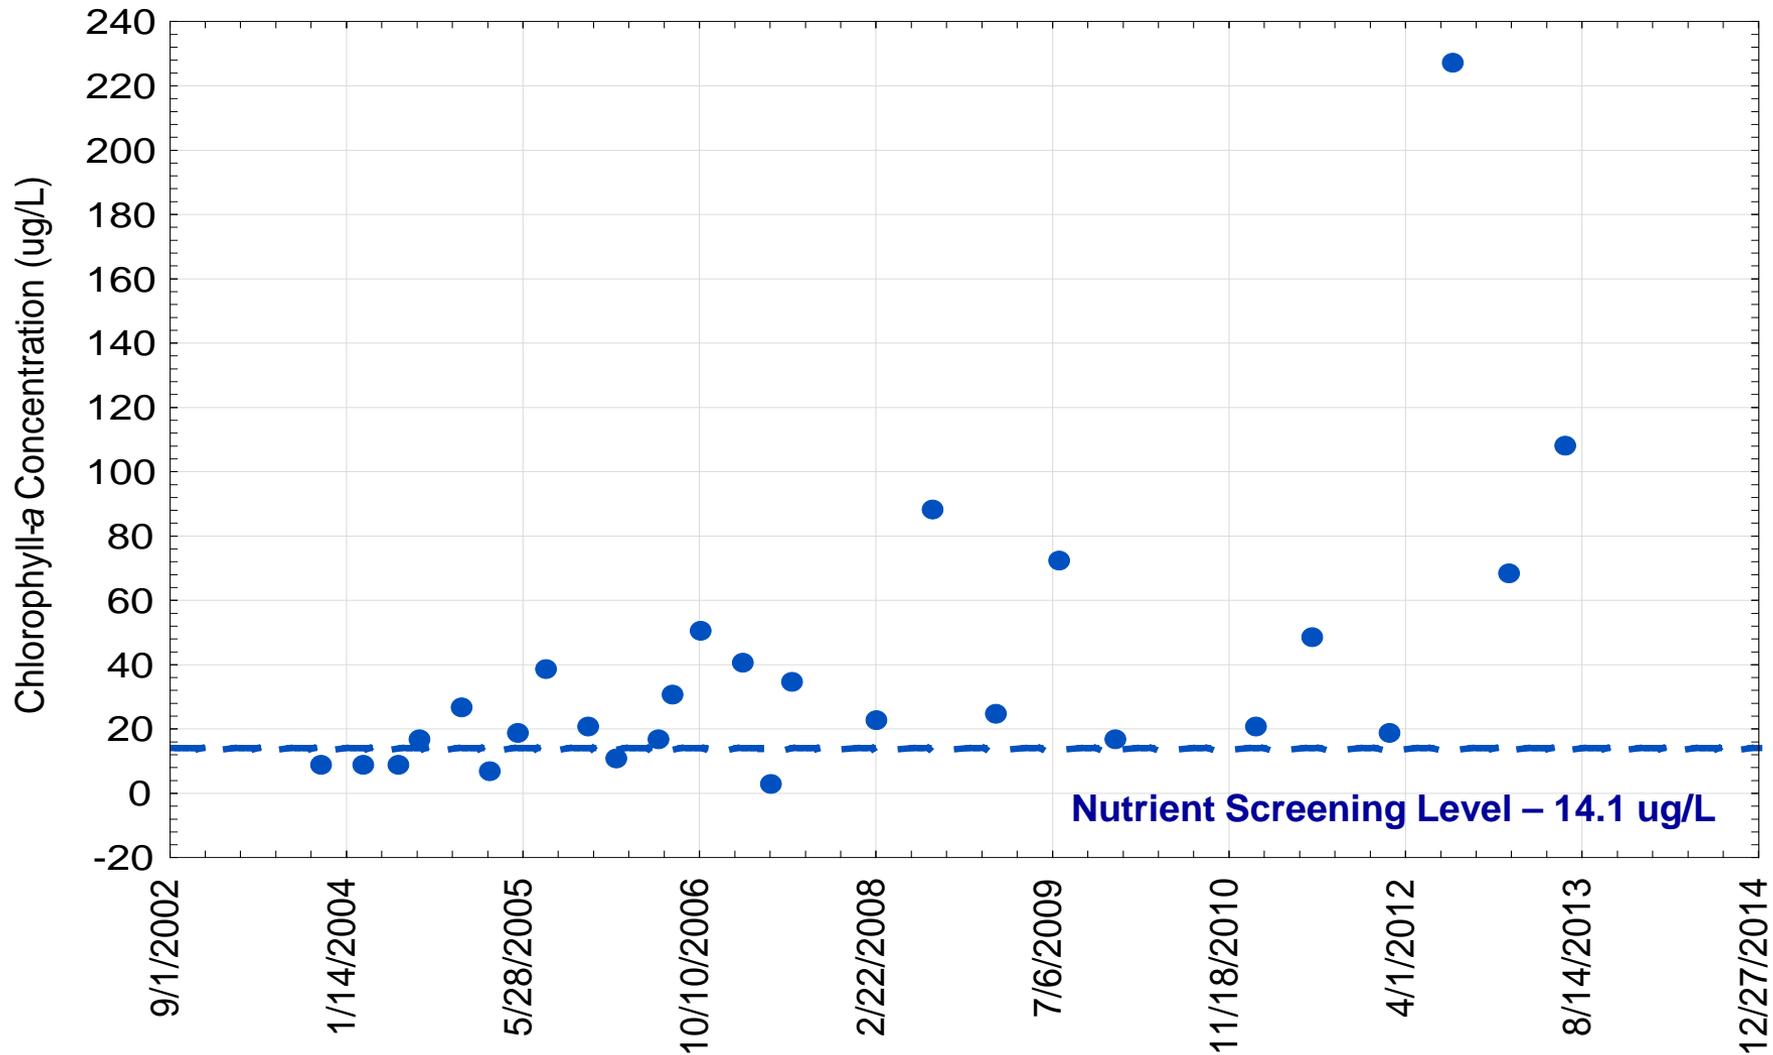
Lake Fryer Mid-Lake
Segment 0104_03
Chlorophylla

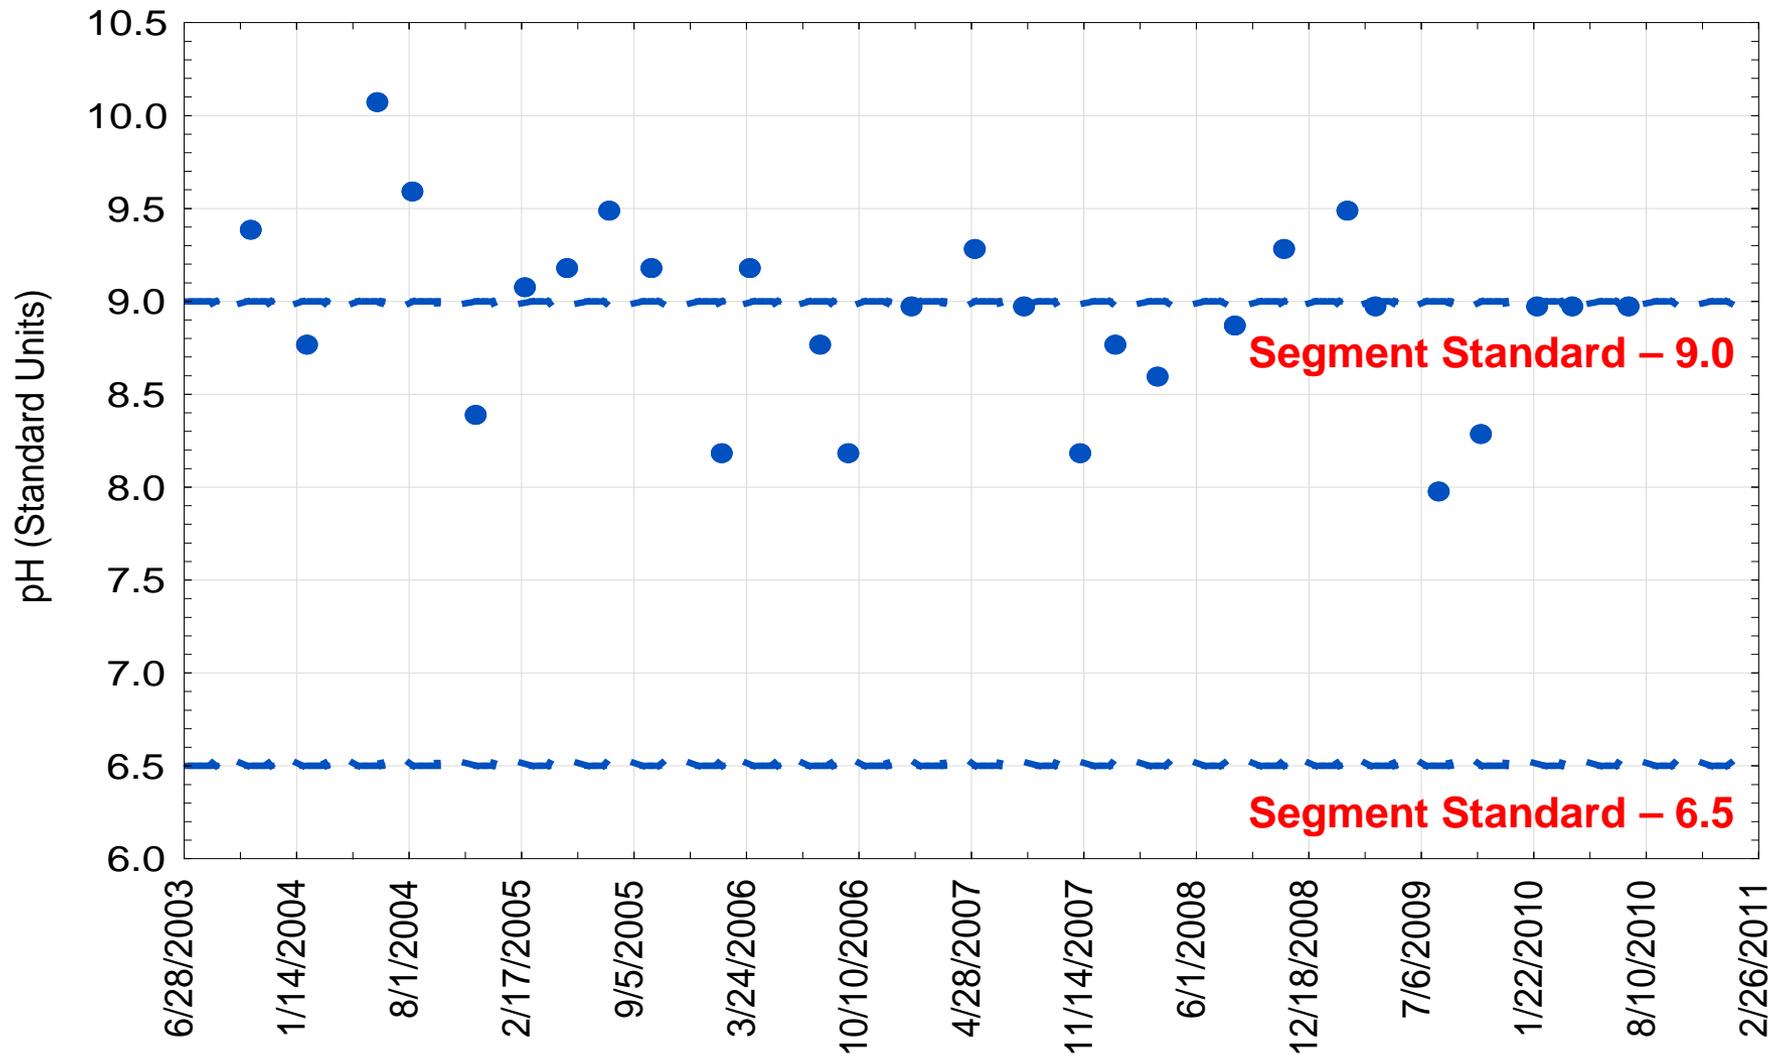
Upper Prairie Dog Town Fork of the Red River
Segment 0229_02
pH

- Lower PDTF Red River (0207)
- Buck Creek (0207A)
- Mackenzie Reservoir (0228)
- Upper PDTF Red River (0229)
 - pH impairment
 - Chlorophyll-*a*, nitrate, **bacteria**, **depressed DO**, and total phosphorus concerns
- Lake Tanglewood (0229A)

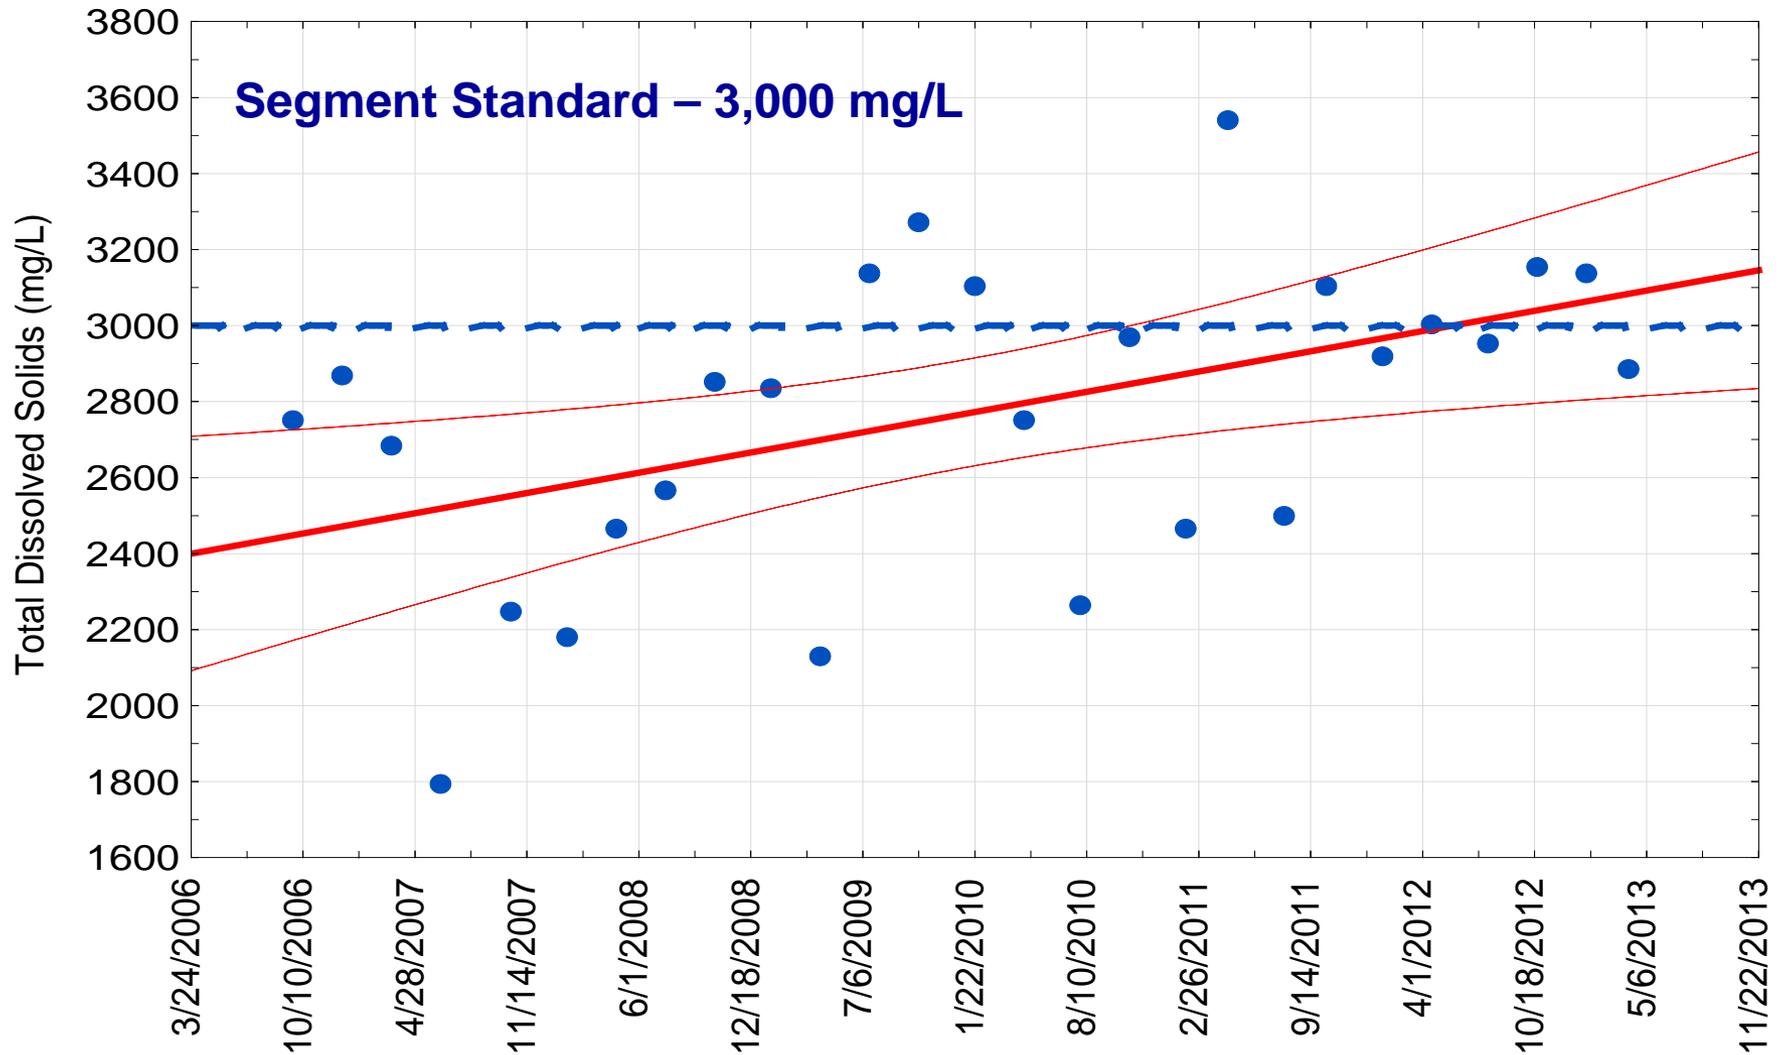
Salt Fork of the Red River
Segment 0222_01
Total Dissolved Solids (TDS)

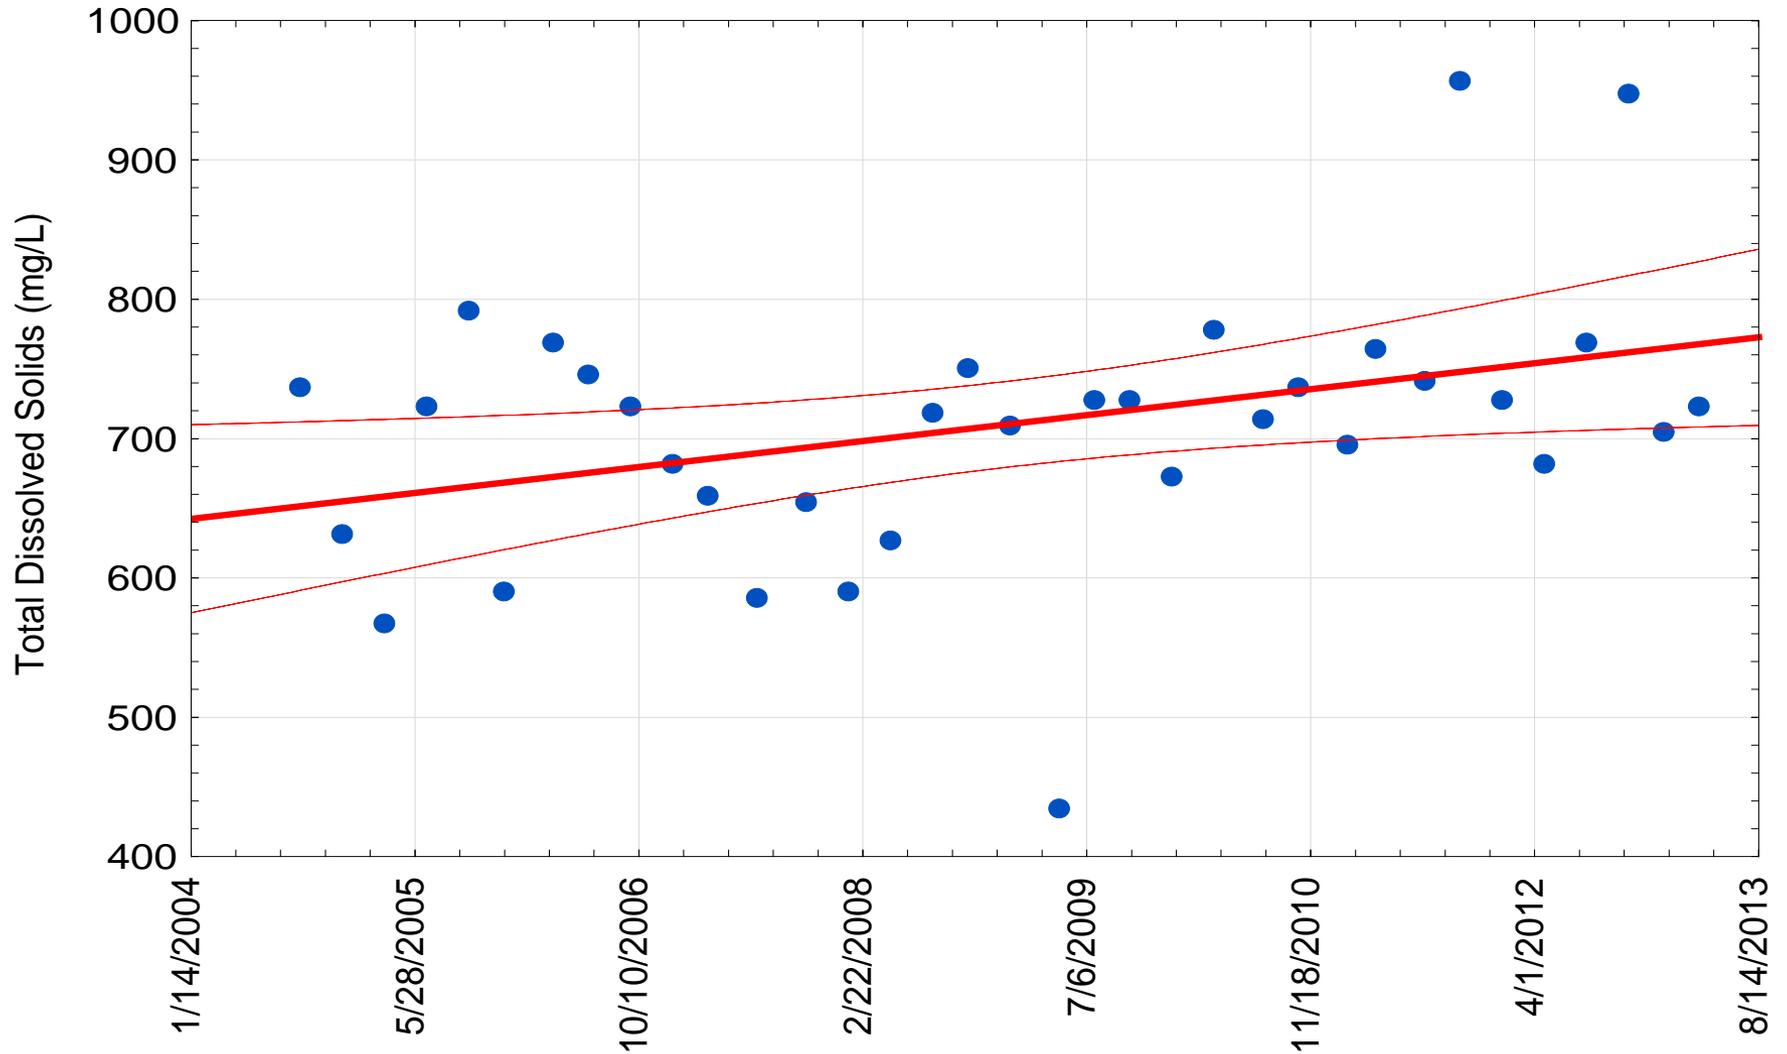
McClellan Creek
Segment 0224A_01
Total Dissolved Solids (TDS)
