FY2015 Basin Highlights Report & FY2016 Coordinated Monitoring

CANADIAN AND RED RIVER BASINS ADVISORY COMMITTEE MEETING

MARCH 17, 2015 – AMARILLO, TEXAS

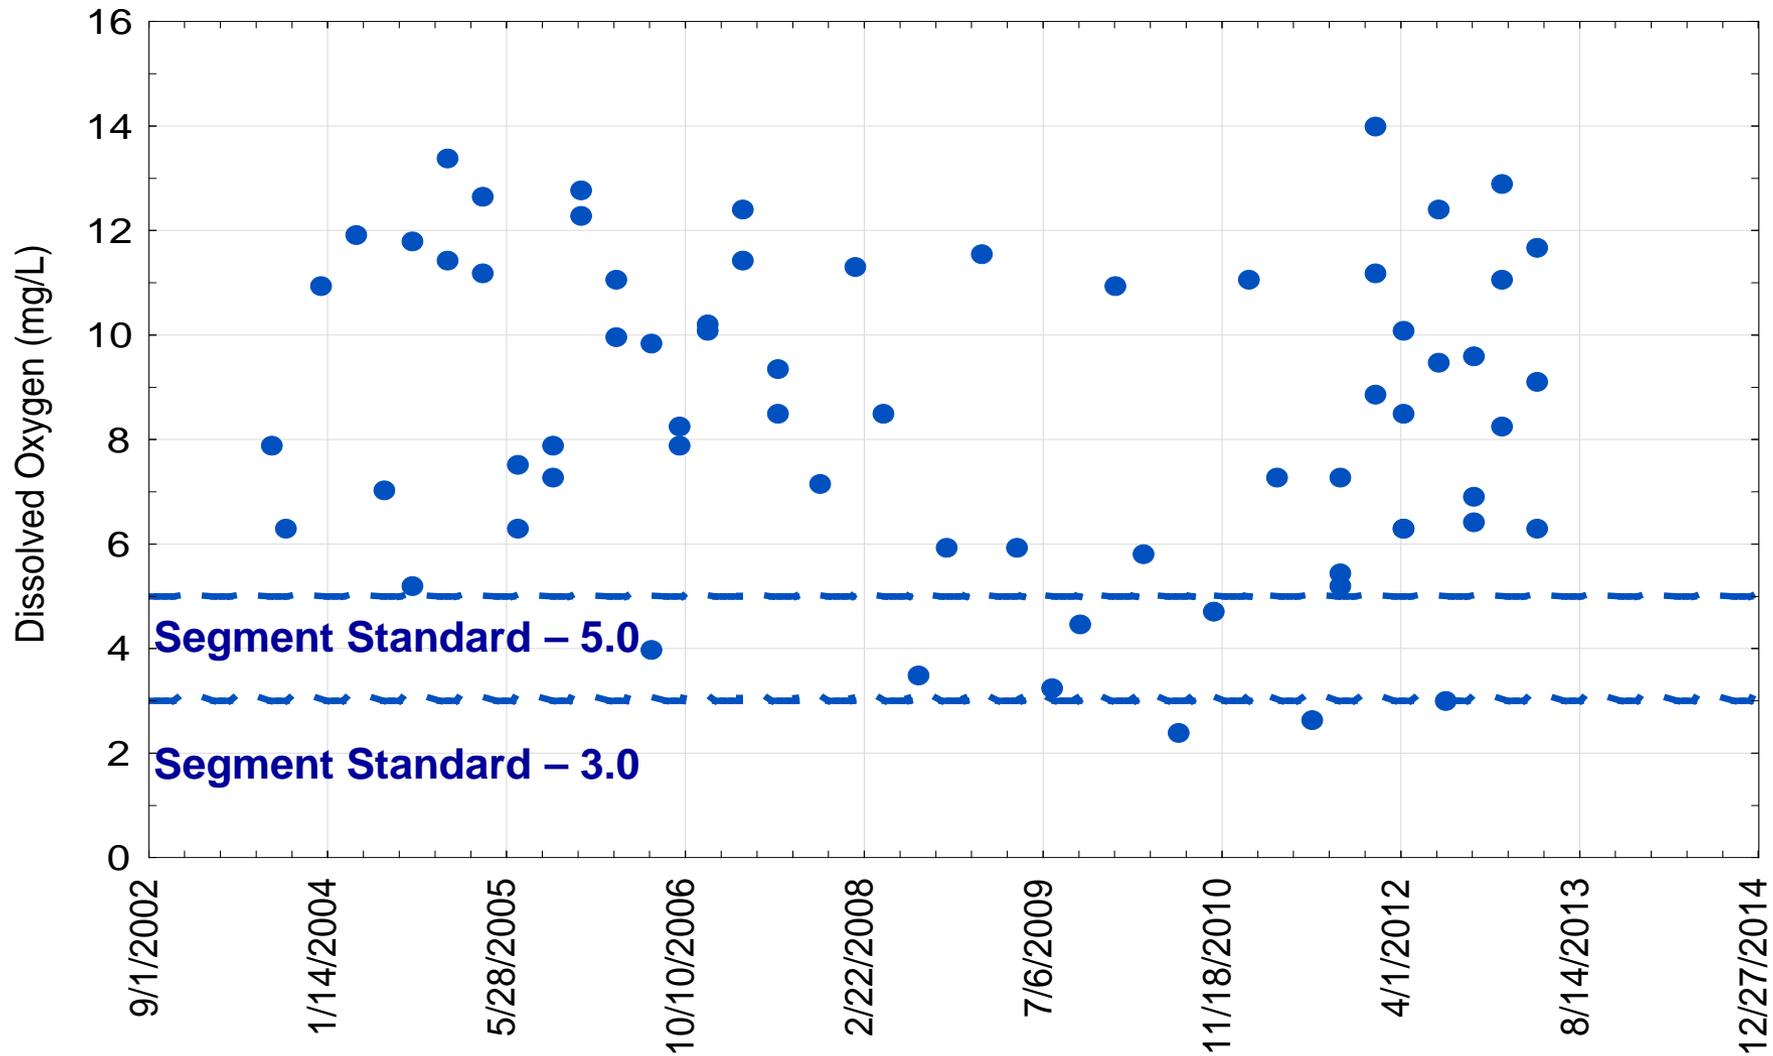
Sweetwater Creek
Segment 0299A_01
Dissolved Oxygen

- Salt Fork of the Red River (0222)
- McClellan Creek (0224A)
- Sweetwater Creek (0299A)
 - No impairments
 - Depressed DO concern
 - RUAA has been completed and submitted to TCEQ
