# **FY2016 Basin Highlights Report & FY2017 Coordinated Monitoring**

**CANADIAN AND RED RIVER  
BASINS ADVISORY COMMITTEE MEETING**

**APRIL 19, 2016 – AMARILLO, TEXAS**

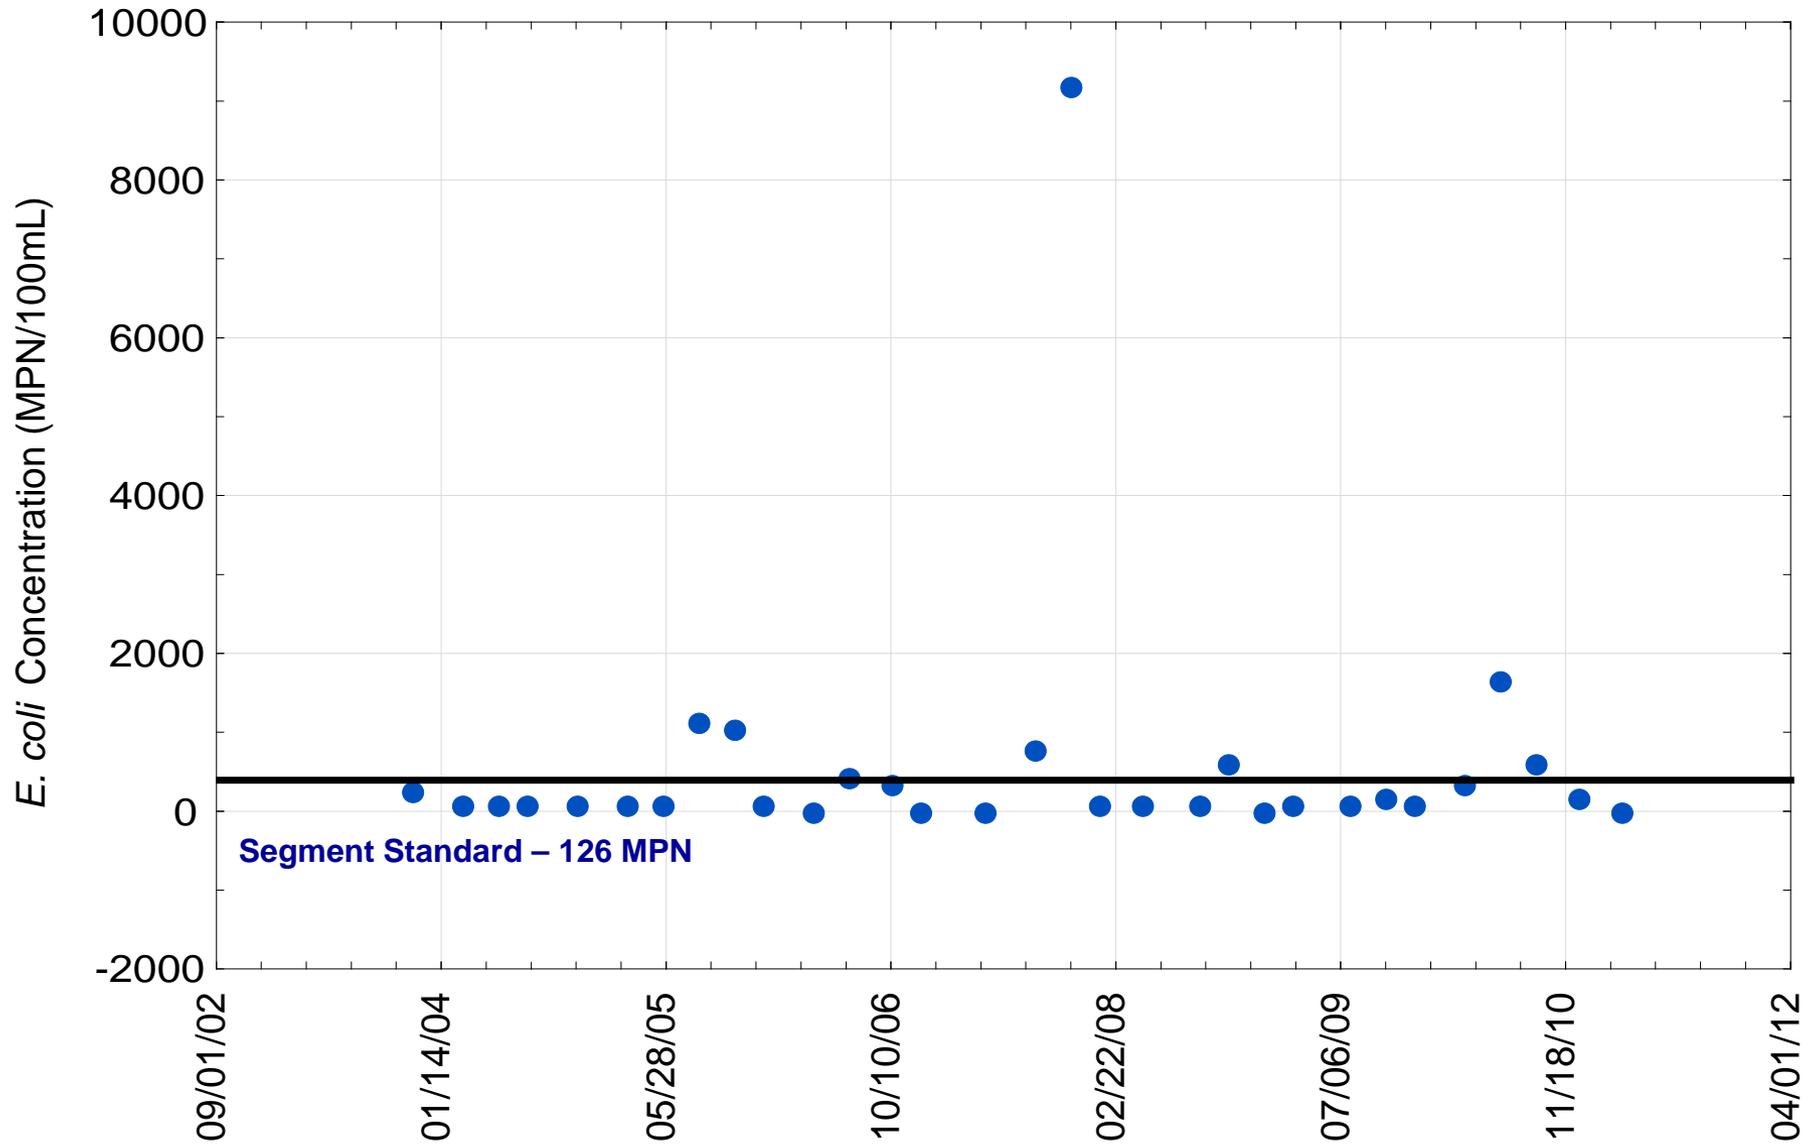
Canadian River Below Lake Meredith  
Segment 0101\_03  
*E. coli*

- Canadian River Below Lake Meredith (0101)
  - **Bacteria impairment**
  - **Chlorophyll-*a*, ammonia, and depressed DO concerns**
- Dixon Creek (0101A)
- Rock Creek (0101B)
- White Deer Creek (0101C)

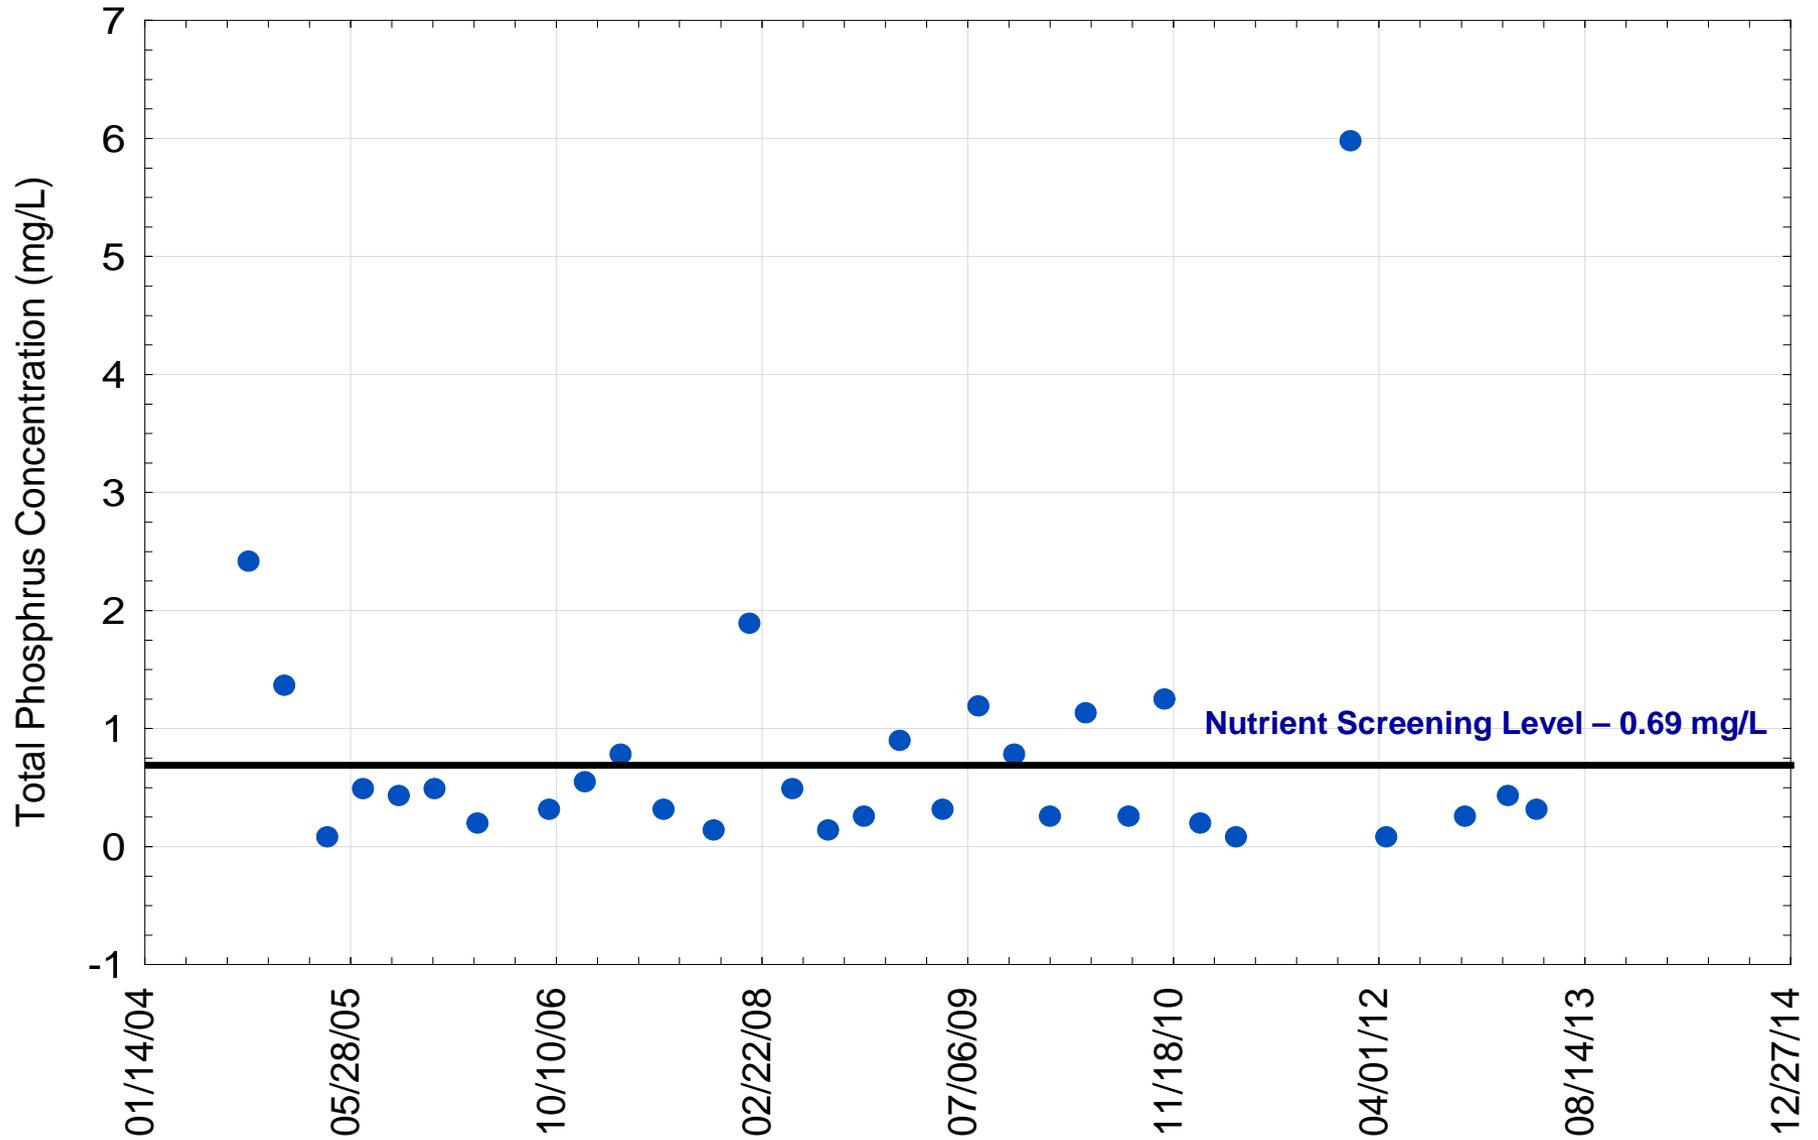
Rock Creek  
Segment 0101B\_01  
Total Phosphorus

- Canadian River Below Lake Meredith (0101)
- Dixon Creek (0101A)
- Rock Creek (0101B)
  - No impairments
  - Nitrate, chlorophyll-*a*, total phosphorus concerns
- White Deer Creek (0101C)

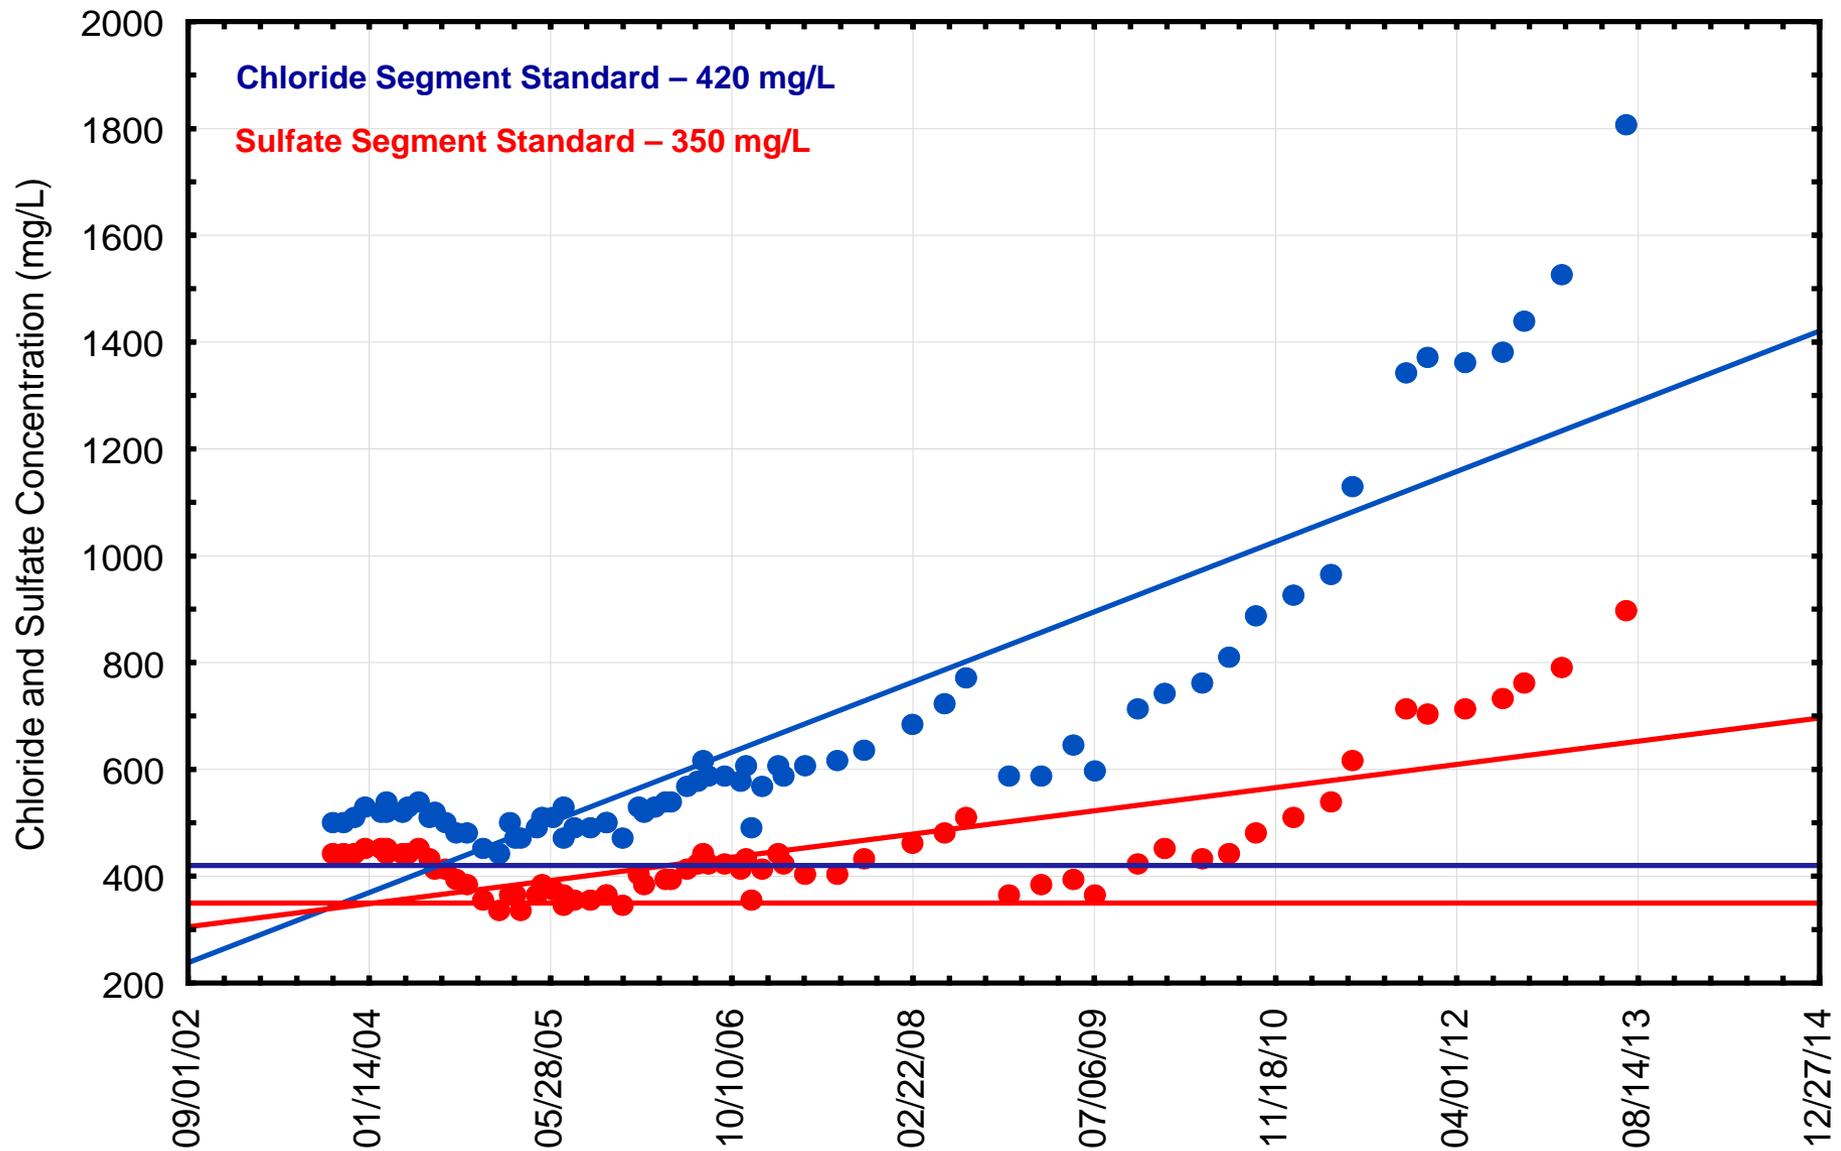
Lake Meredith  
Segment 0102\_01  
Chloride and Sulfate

- Lake Meredith (0102)
  - Mercury in edible fish tissue, chloride, sulfate, TDS impairments
  - No concerns
- Canadian River Above Lake Meredith (0103)
- Big Blue Creek (0102A)
- East Amarillo Creek (0103A)
- Unnamed Tributary to West Amarillo Creek (0103C)

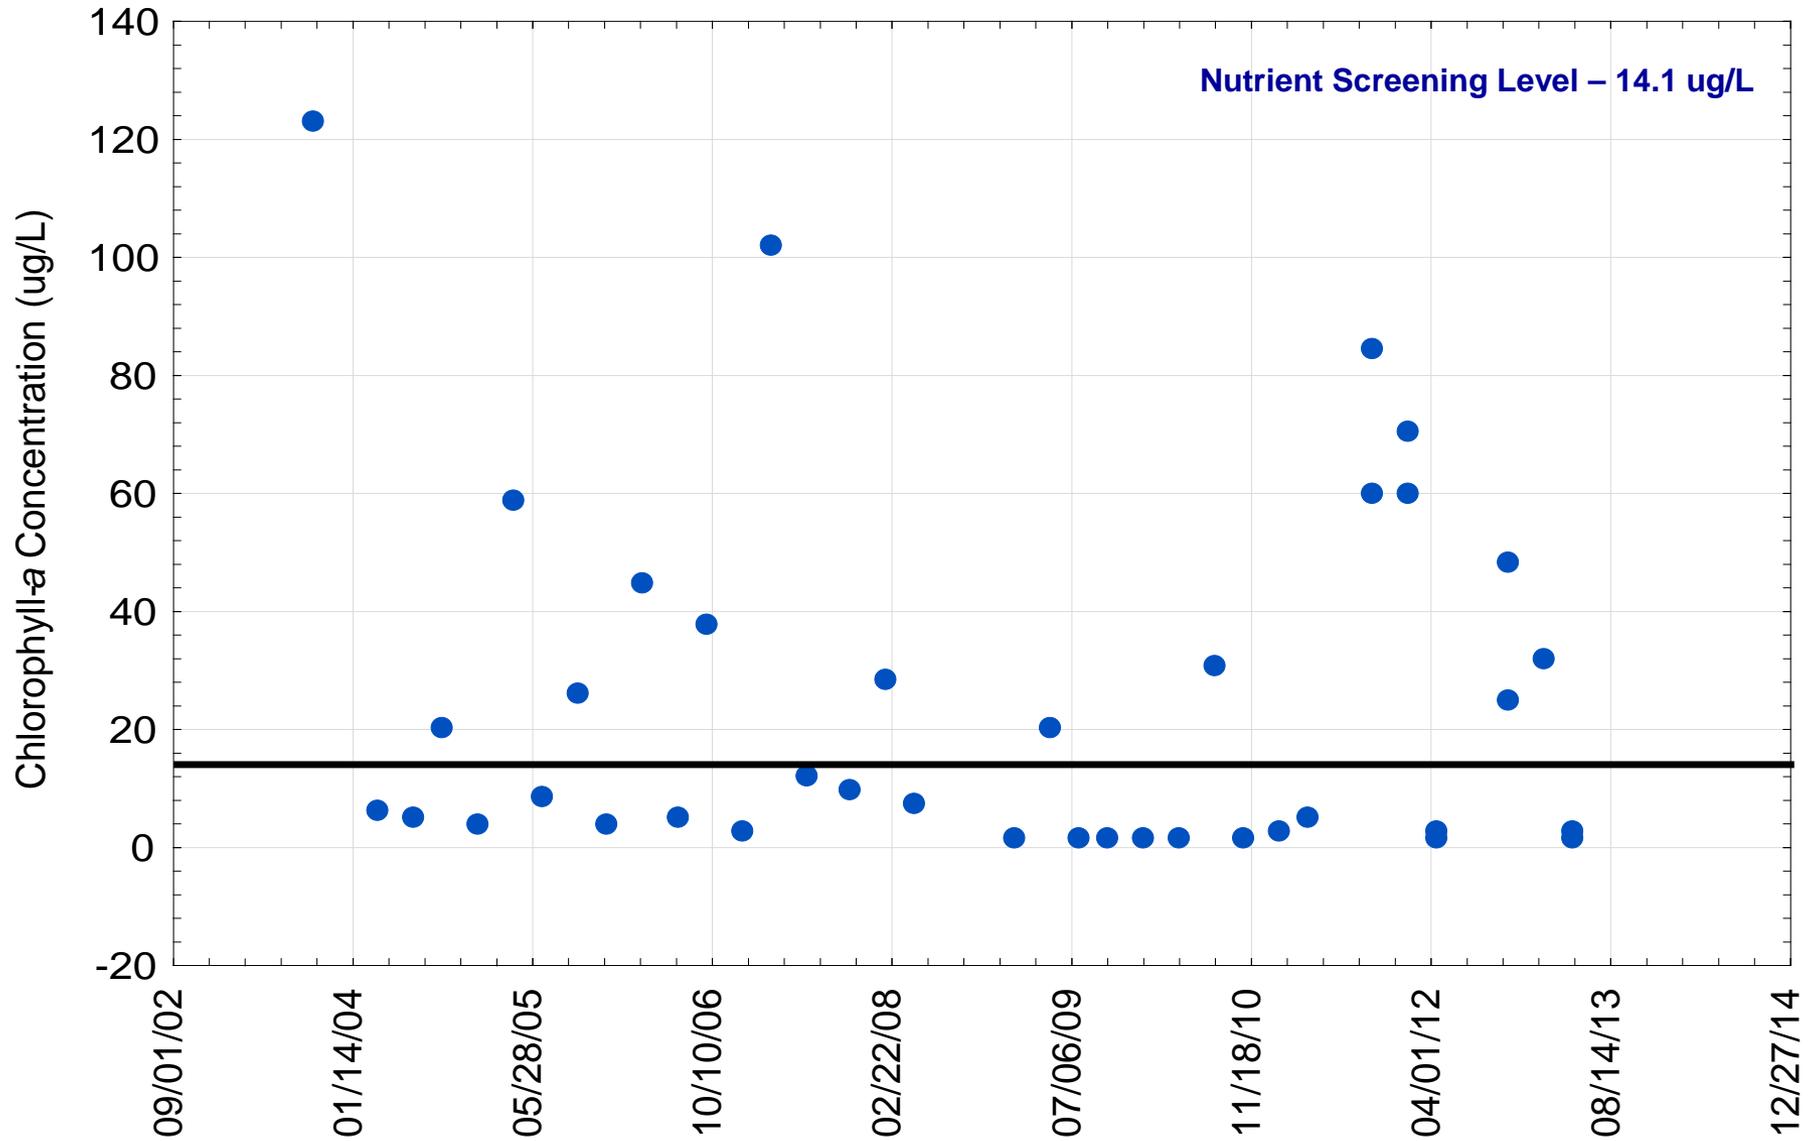
East Amarillo Creek  
Segment 0103A\_01  
Chlorophyll -a

- Lake Meredith (0102)
- Big Blue Creek (0102A)
- Canadian River Above Lake Meredith (0103)
- Big Blue Creek (0102A)
- East Amarillo Creek (0103A)
  - **No impairments**
  - **Chlorophyll-*a* and nitrate concerns**
- Unnamed Tributary to West Amarillo Creek (0103C)

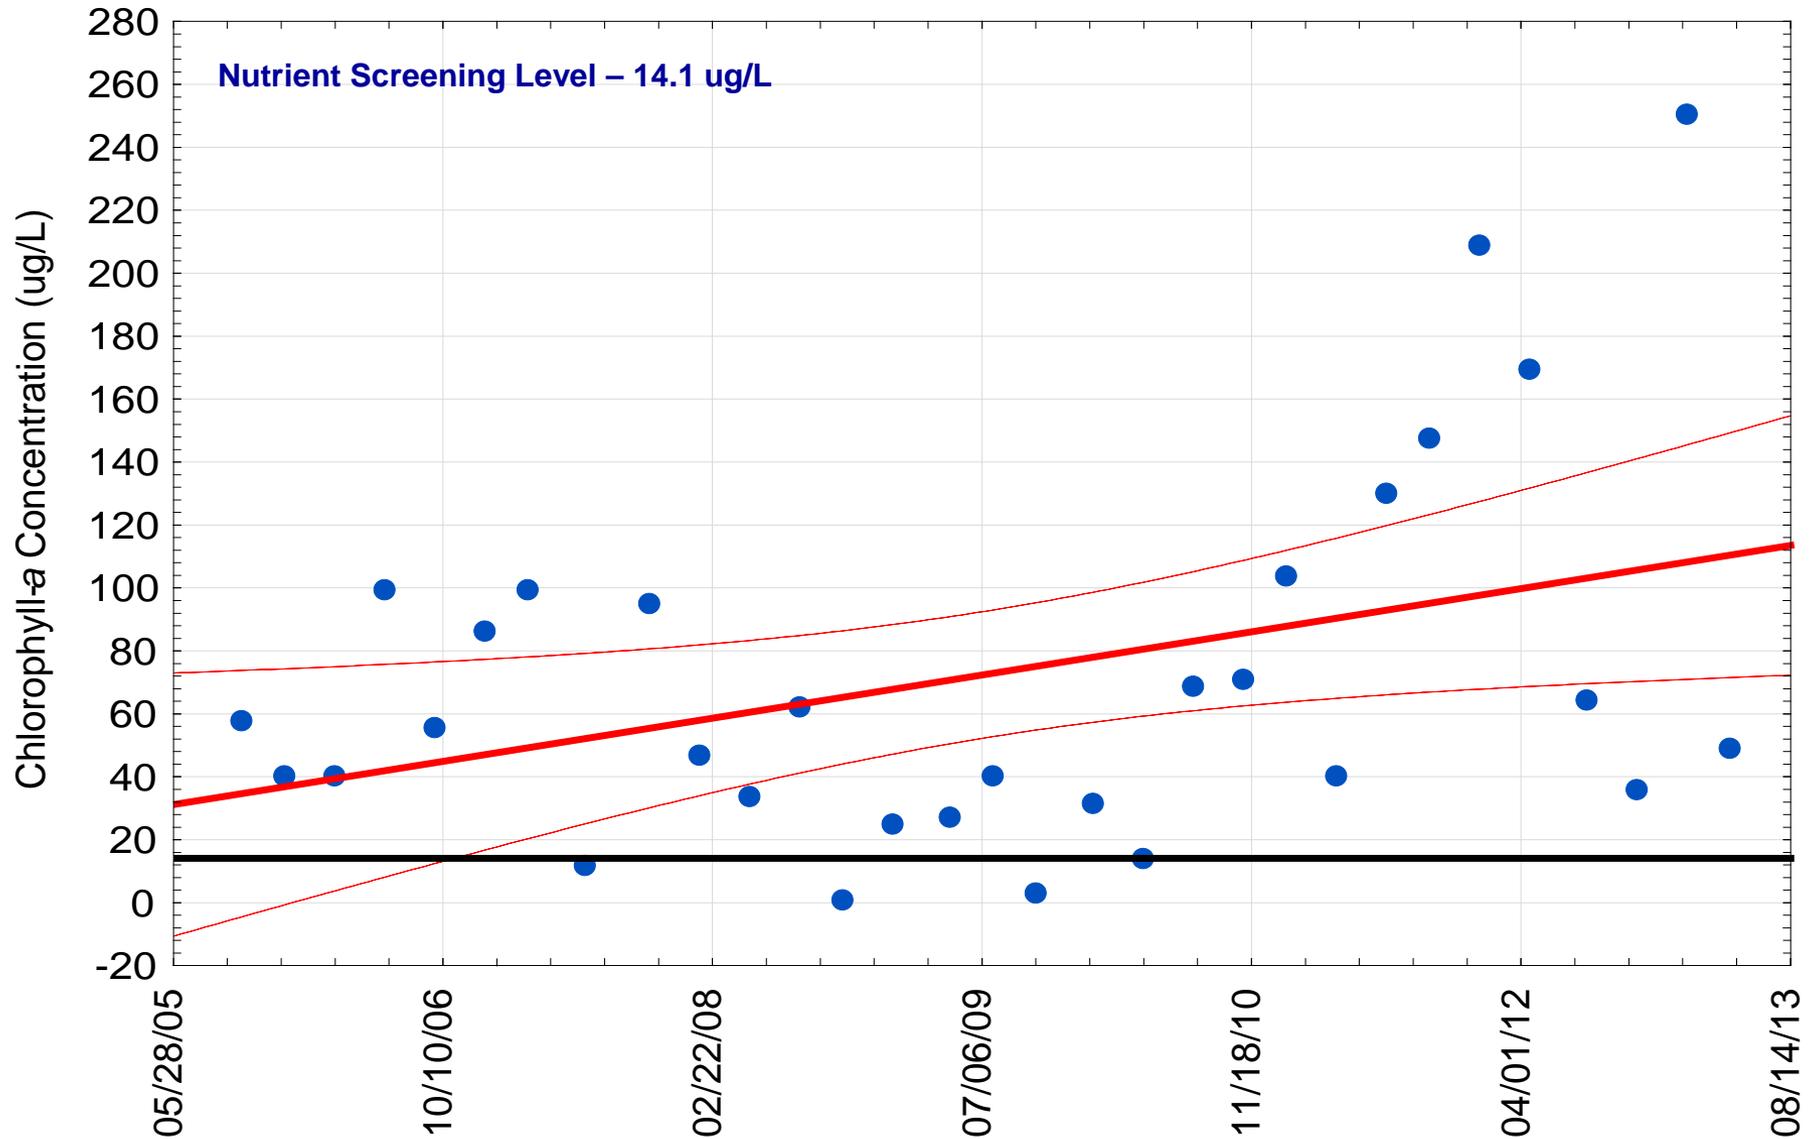
East Amarillo Creek  
Segment 0103A\_02  
Chlorophyll -a

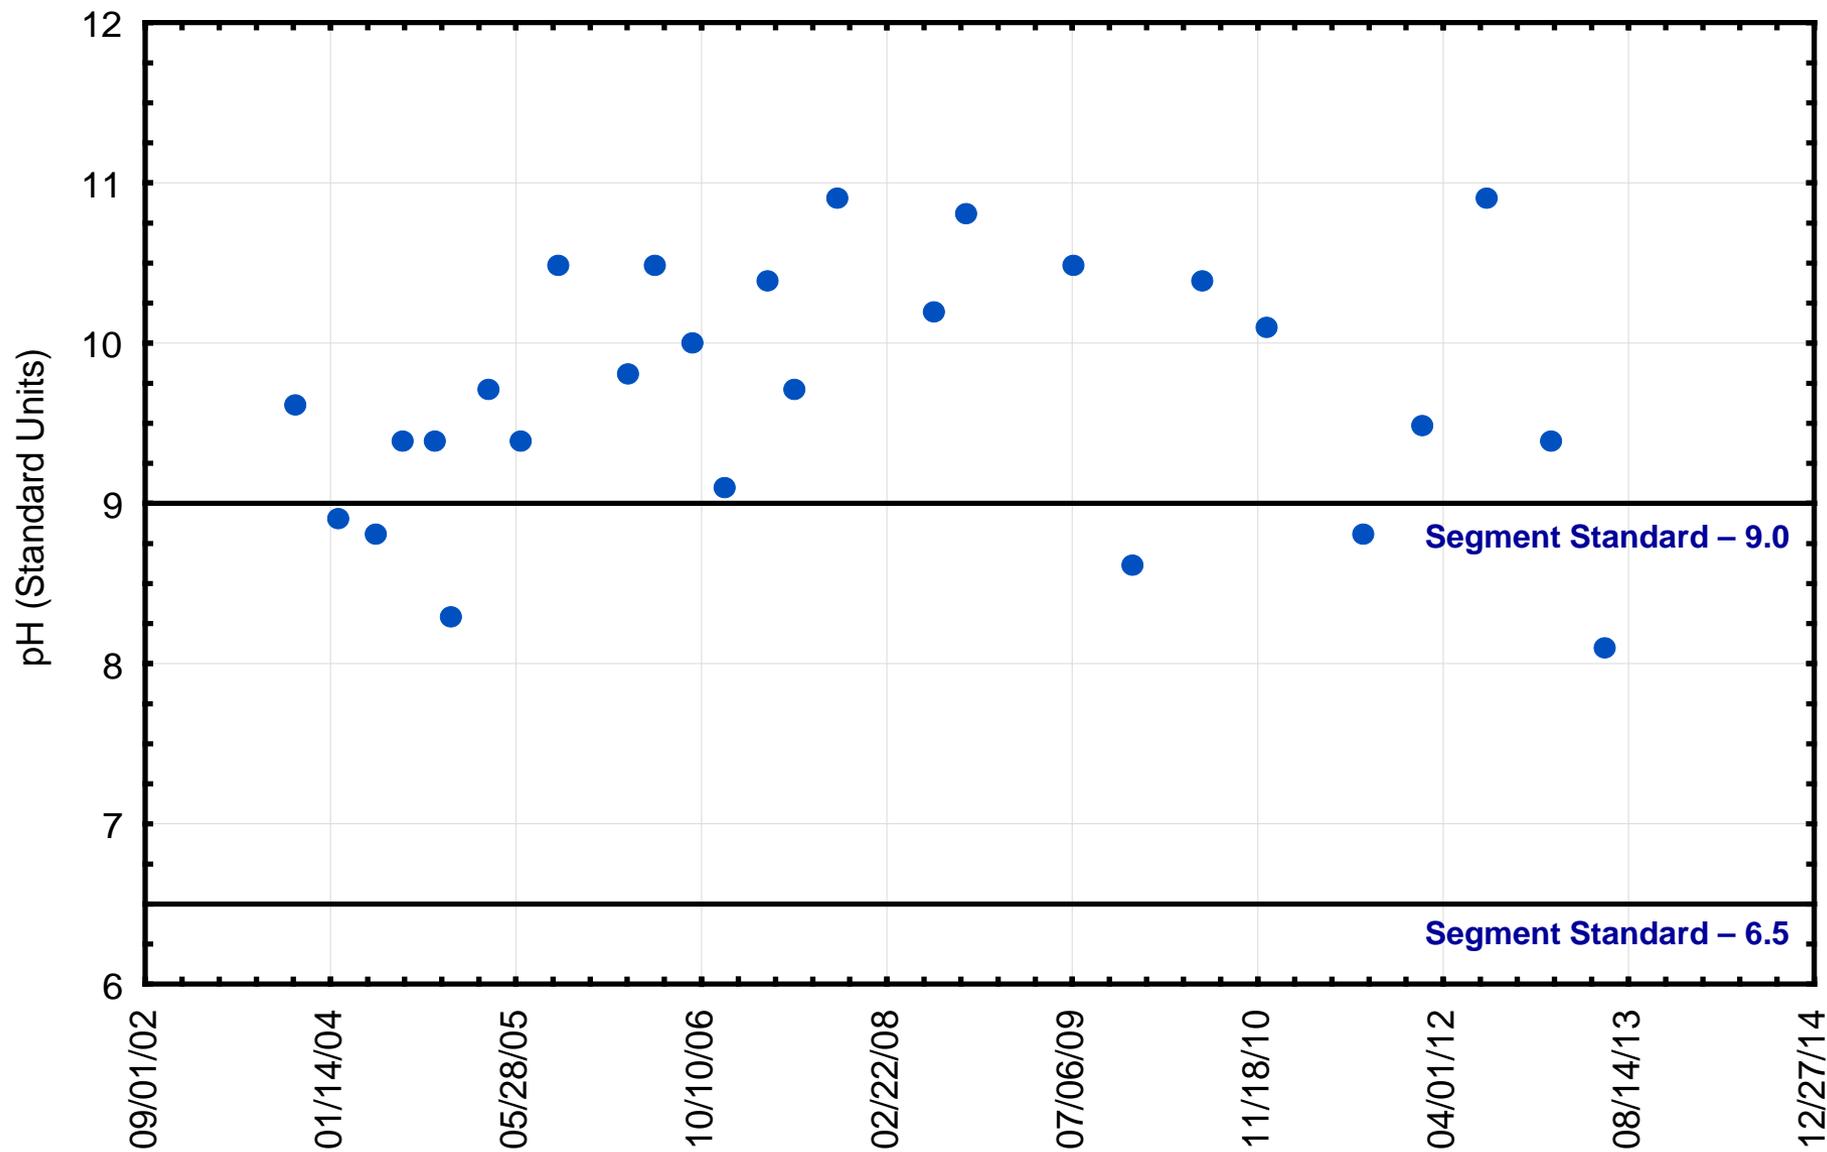
Rita Blanca Lake  
Segment 0105\_01  
pH

- Rita Blanca Lake (0105)
  - pH and **chloride** impairment
  - Ammonia, chlorophyll-*a*, nitrate, total phosphorus concerns

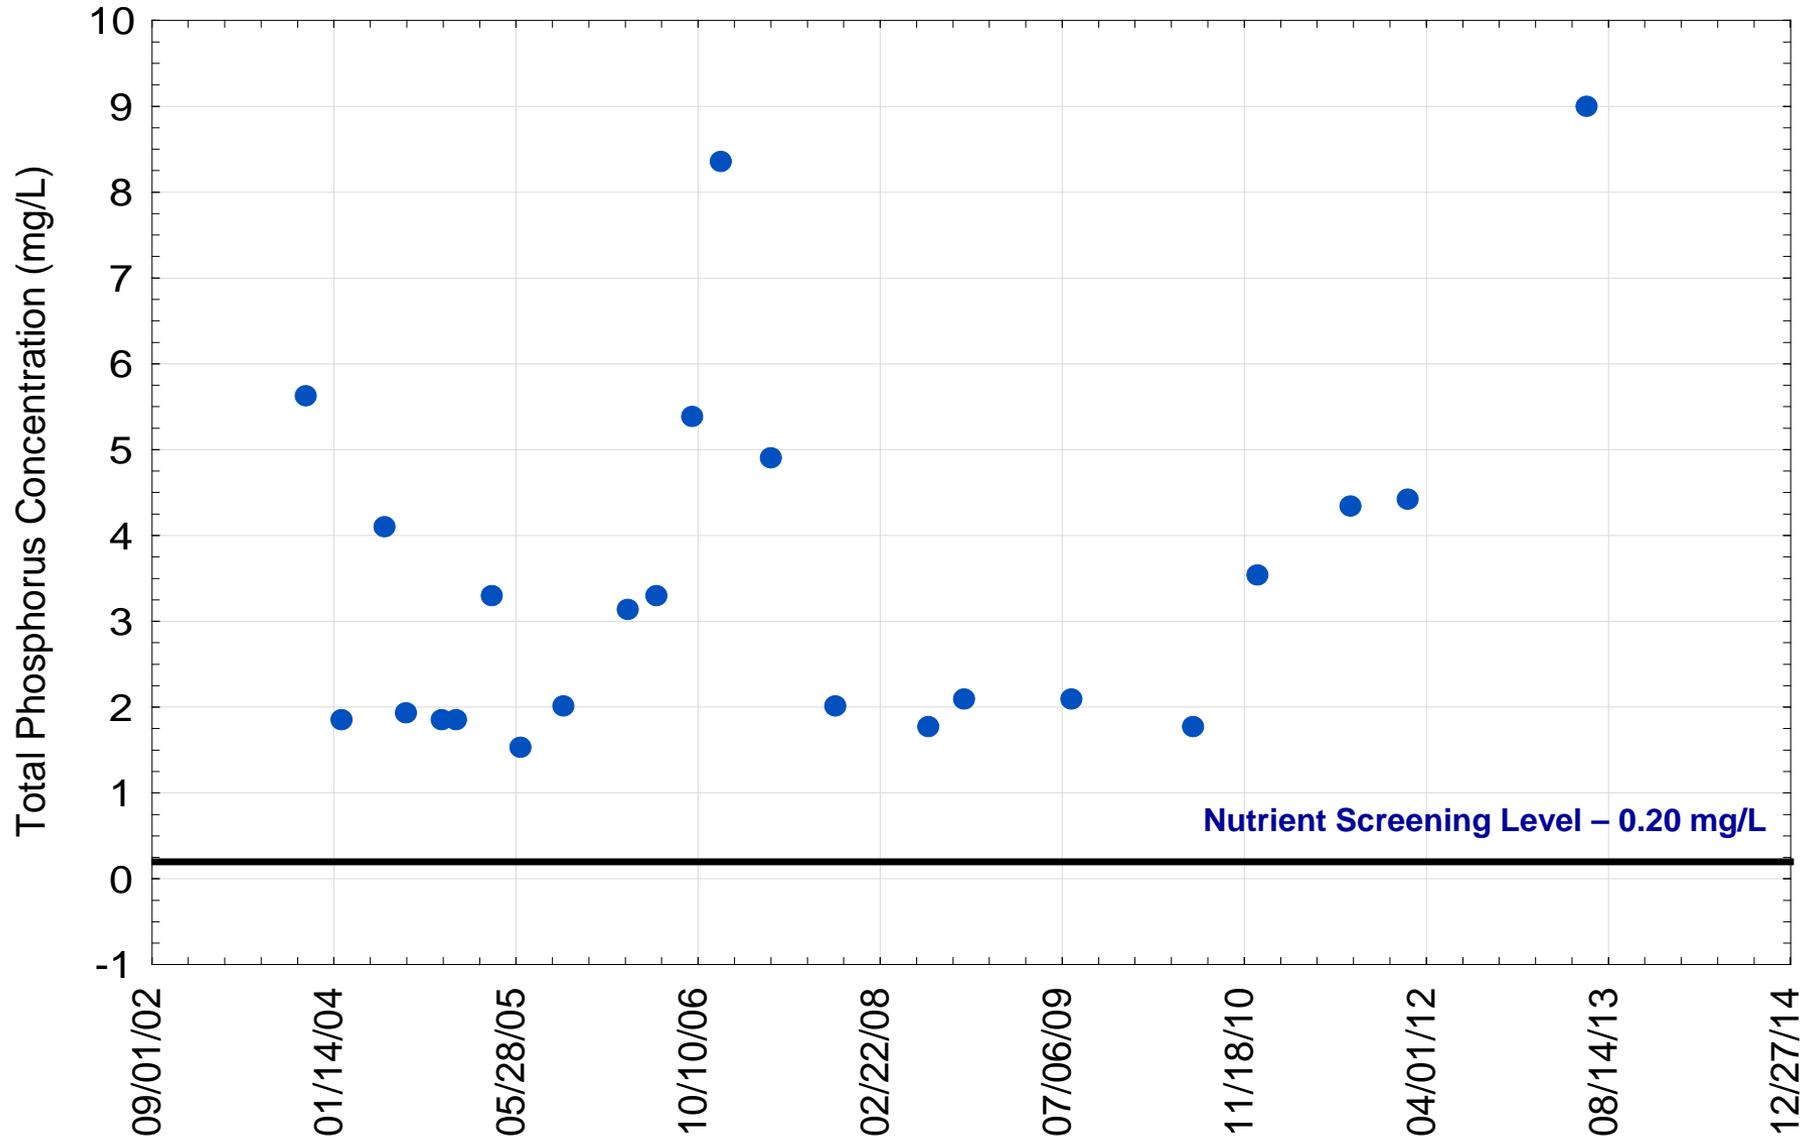
Rita Blanca Lake  
Segment 0105\_01  
Total Phosphorus

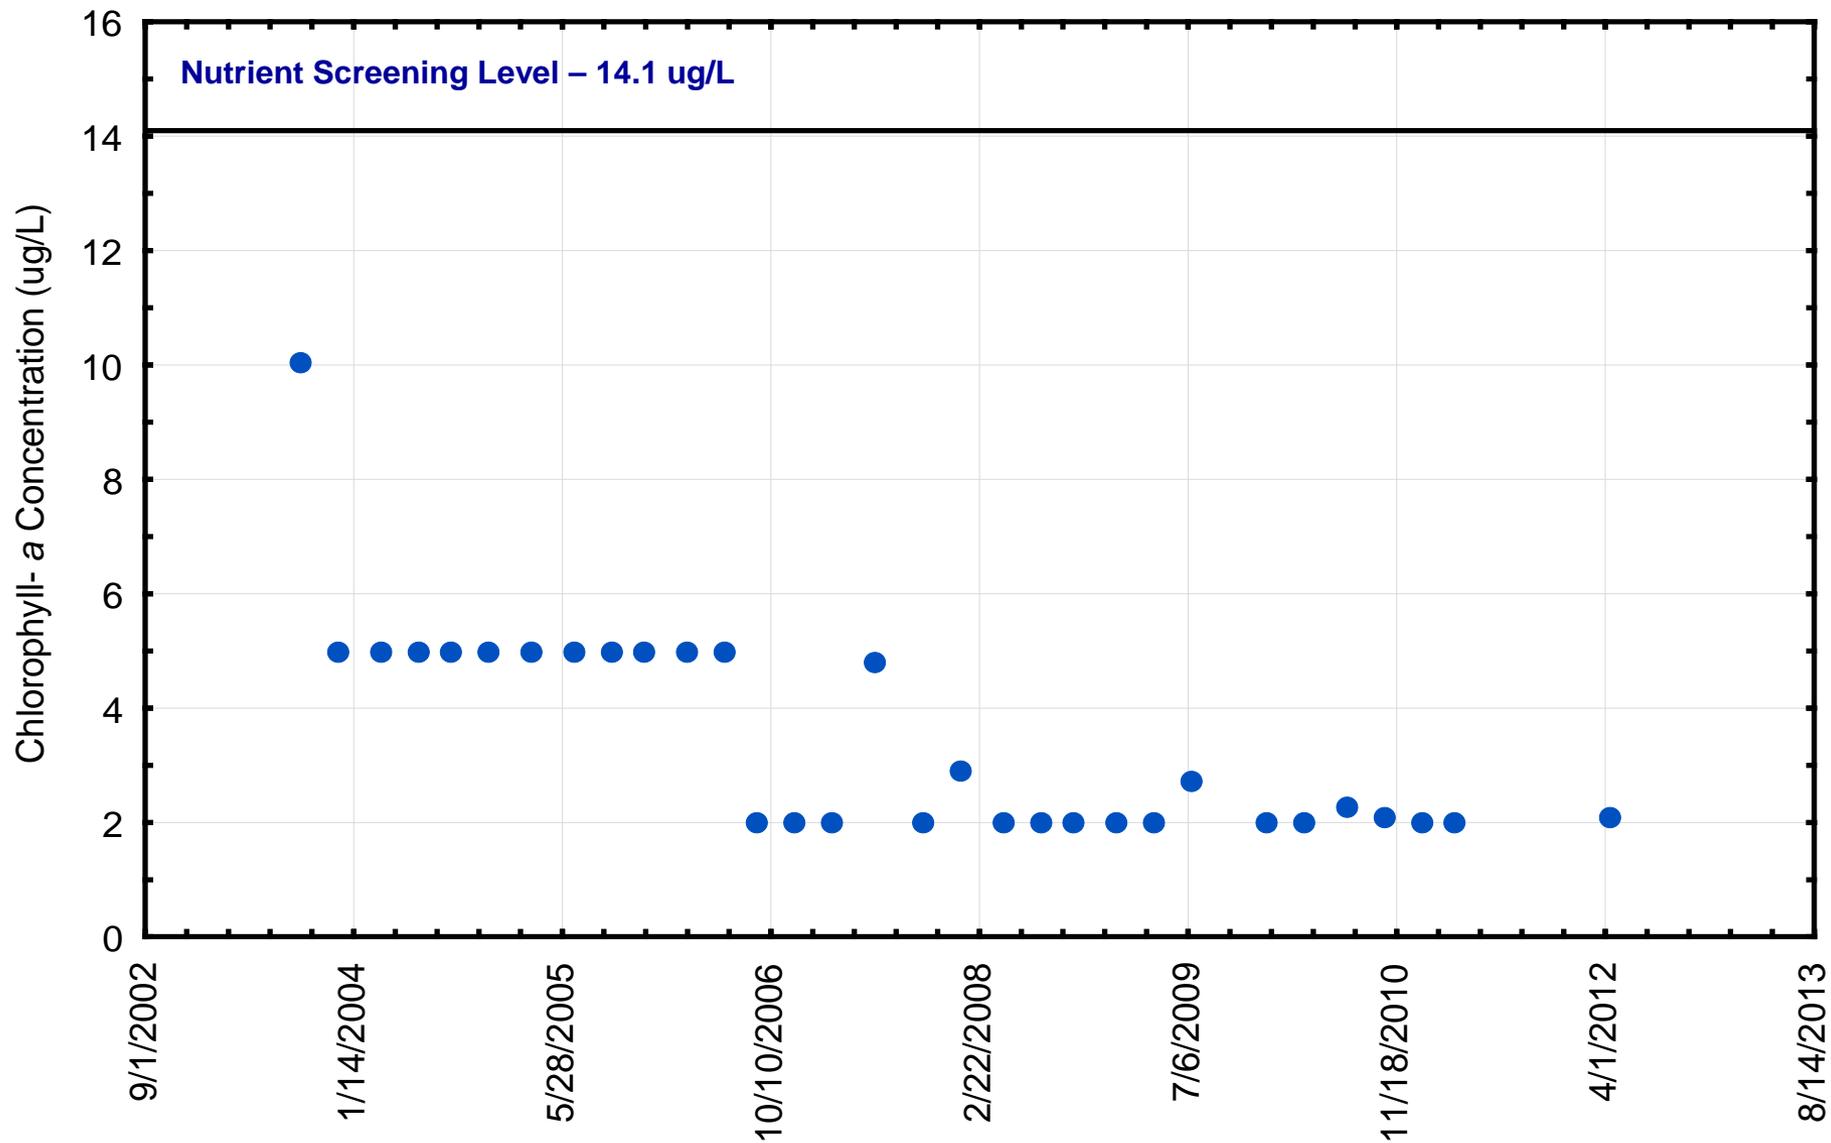
Wolf Creek at FM 1454  
Segment 0104\_01  
Chlorophyll-*a*

- **Wolf Creek (0104)**
  - **No impairments**
  - **Chlorophyll-a concern**
  - **Aquatic Life Monitoring – May 2016**
- **Kiowa Creek (0199B)**

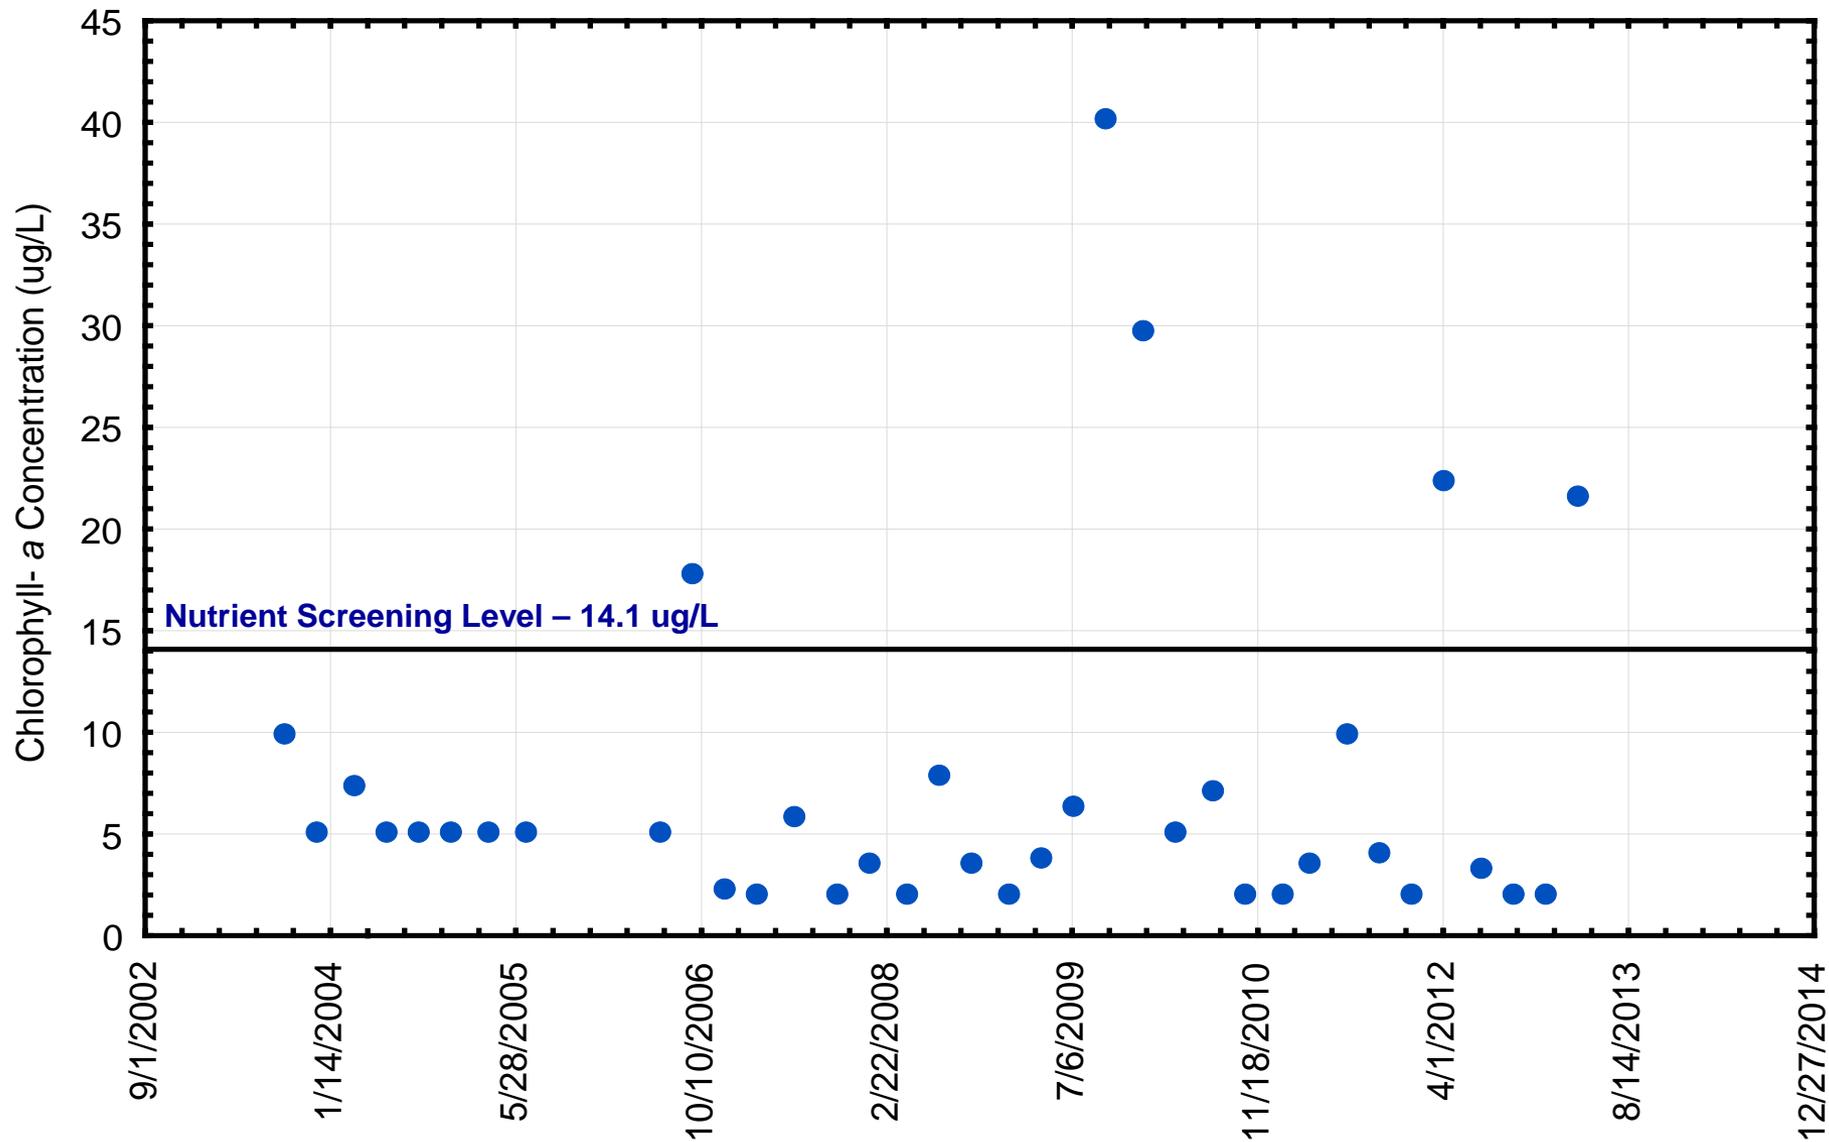
Wolf Creek at SH 305  
Segment 0104\_02  
Chlorophyll-a

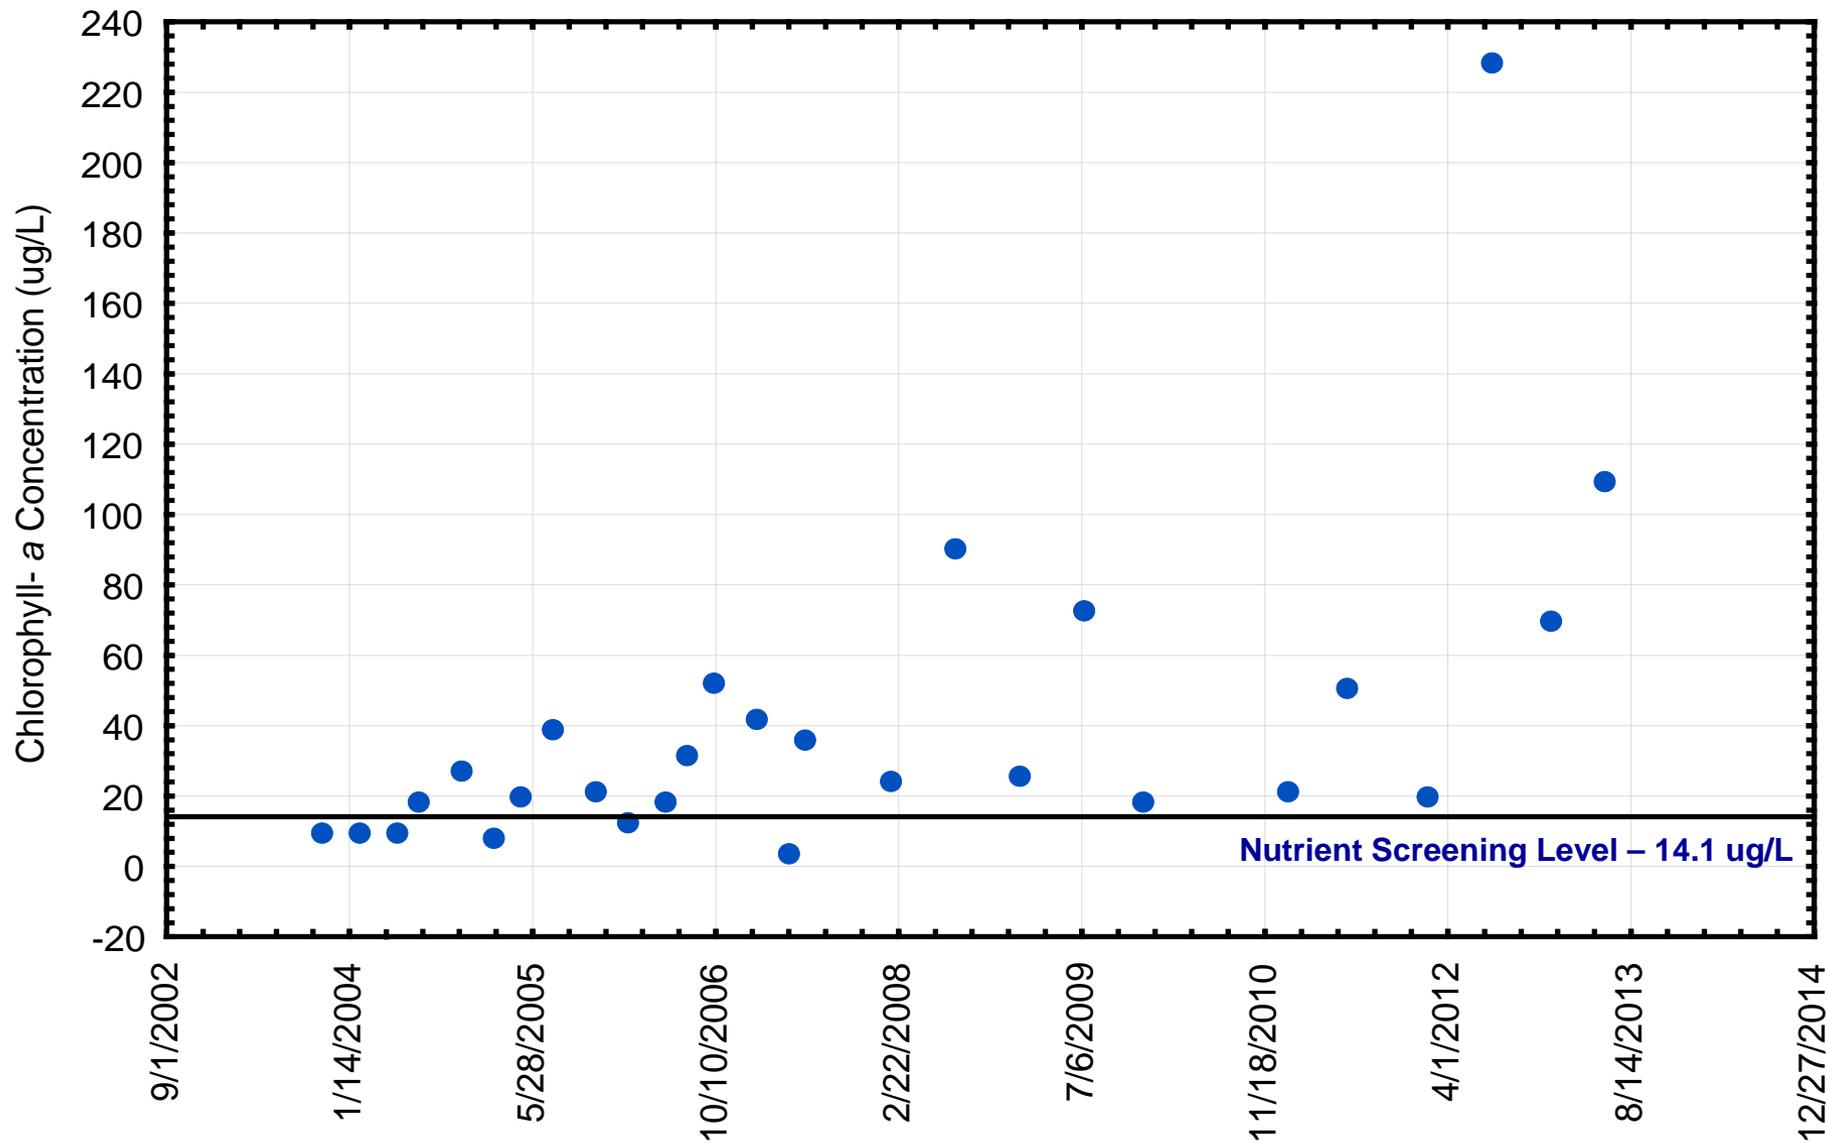
Lake Fryer Mid-Lake  
Segment 0104\_03  
Chlorophyll-a
