# **FY2016 Basin Highlights Report & FY2017 Coordinated Monitoring**

**CANADIAN AND RED RIVER  
BASINS ADVISORY COMMITTEE MEETING**

**APRIL 19, 2016 – AMARILLO, TEXAS**

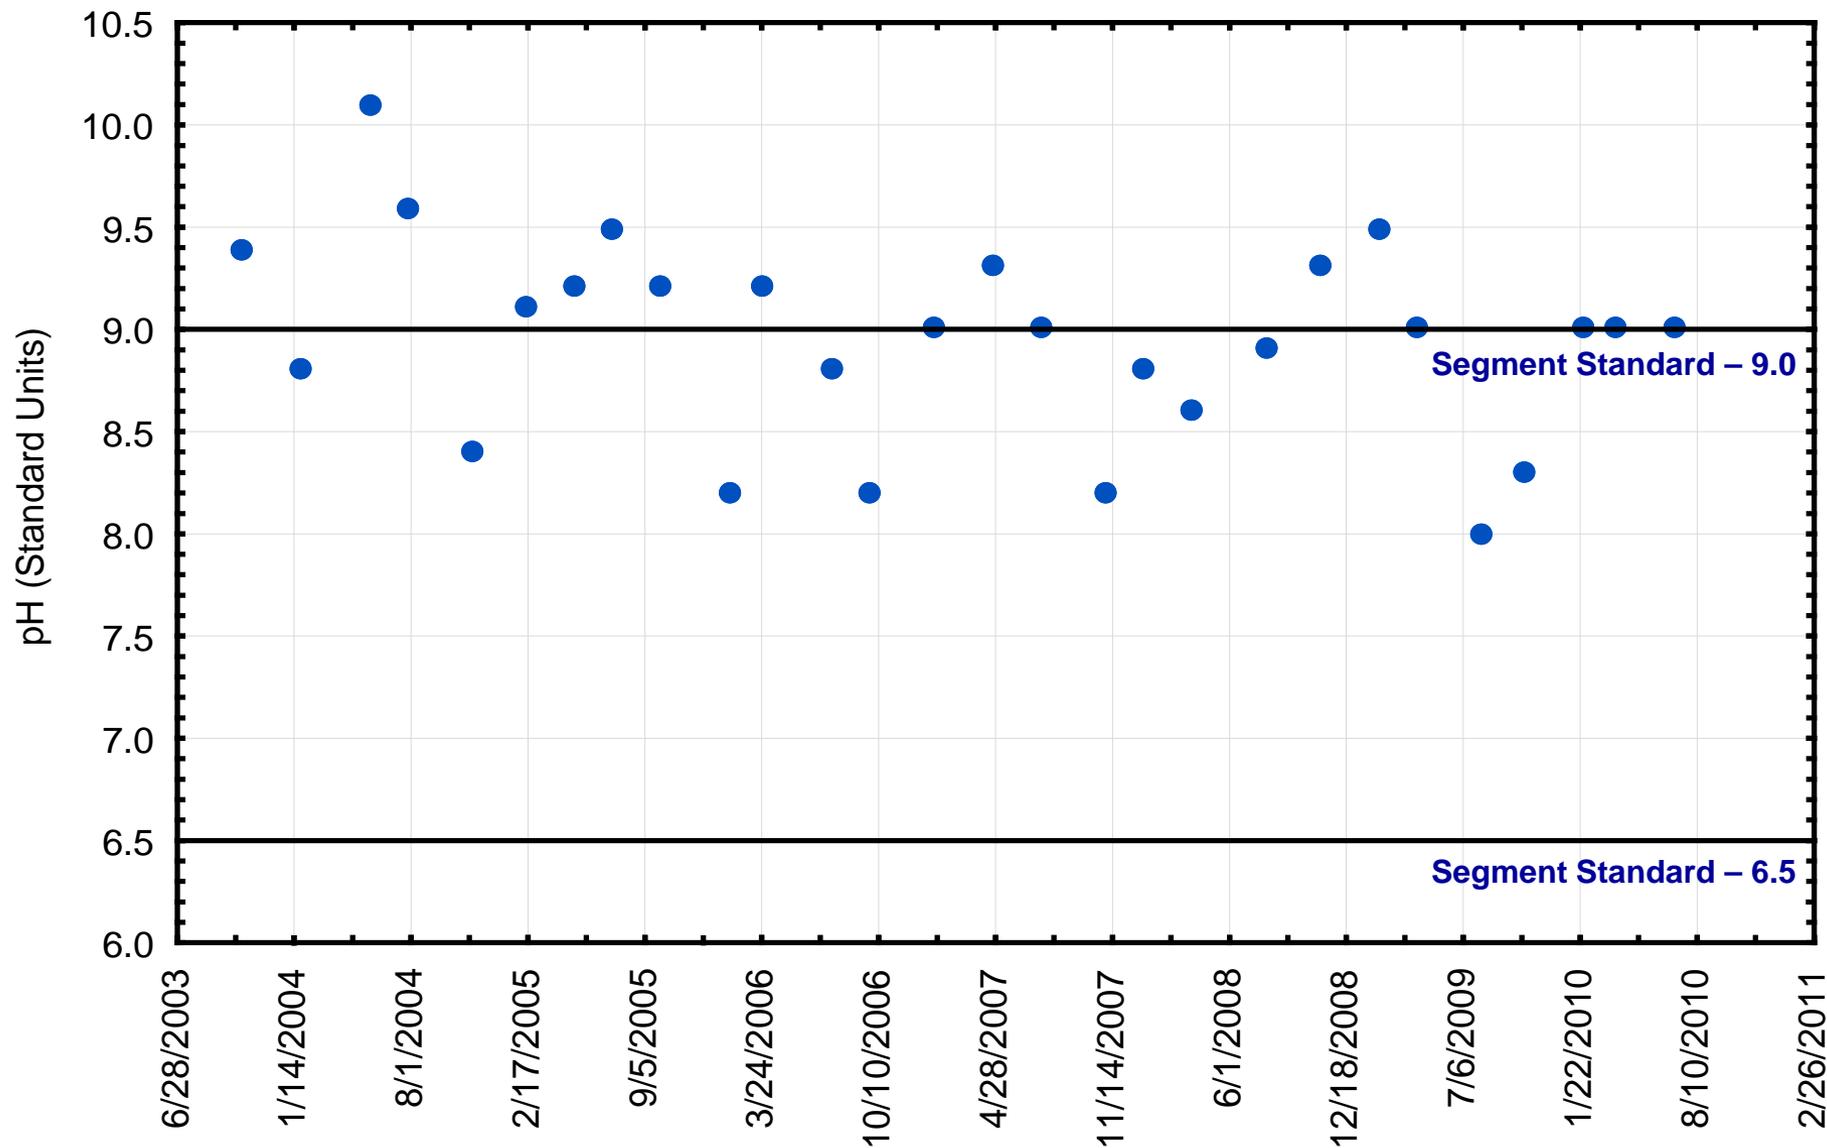
Upper Prairie Dog Town Fork of the Red River  
Segment 0229\_02  
pH

- Lower PDTF Red River (0207)
- Buck Creek (0207A)
- Mackenzie Reservoir (0228)
- Upper PDTF Red River (0229)
  - pH impairment
  - Chlorophyll-*a*, nitrate, **bacteria**, **depressed DO**, and total phosphorus concerns
- Lake Tanglewood (0229A)

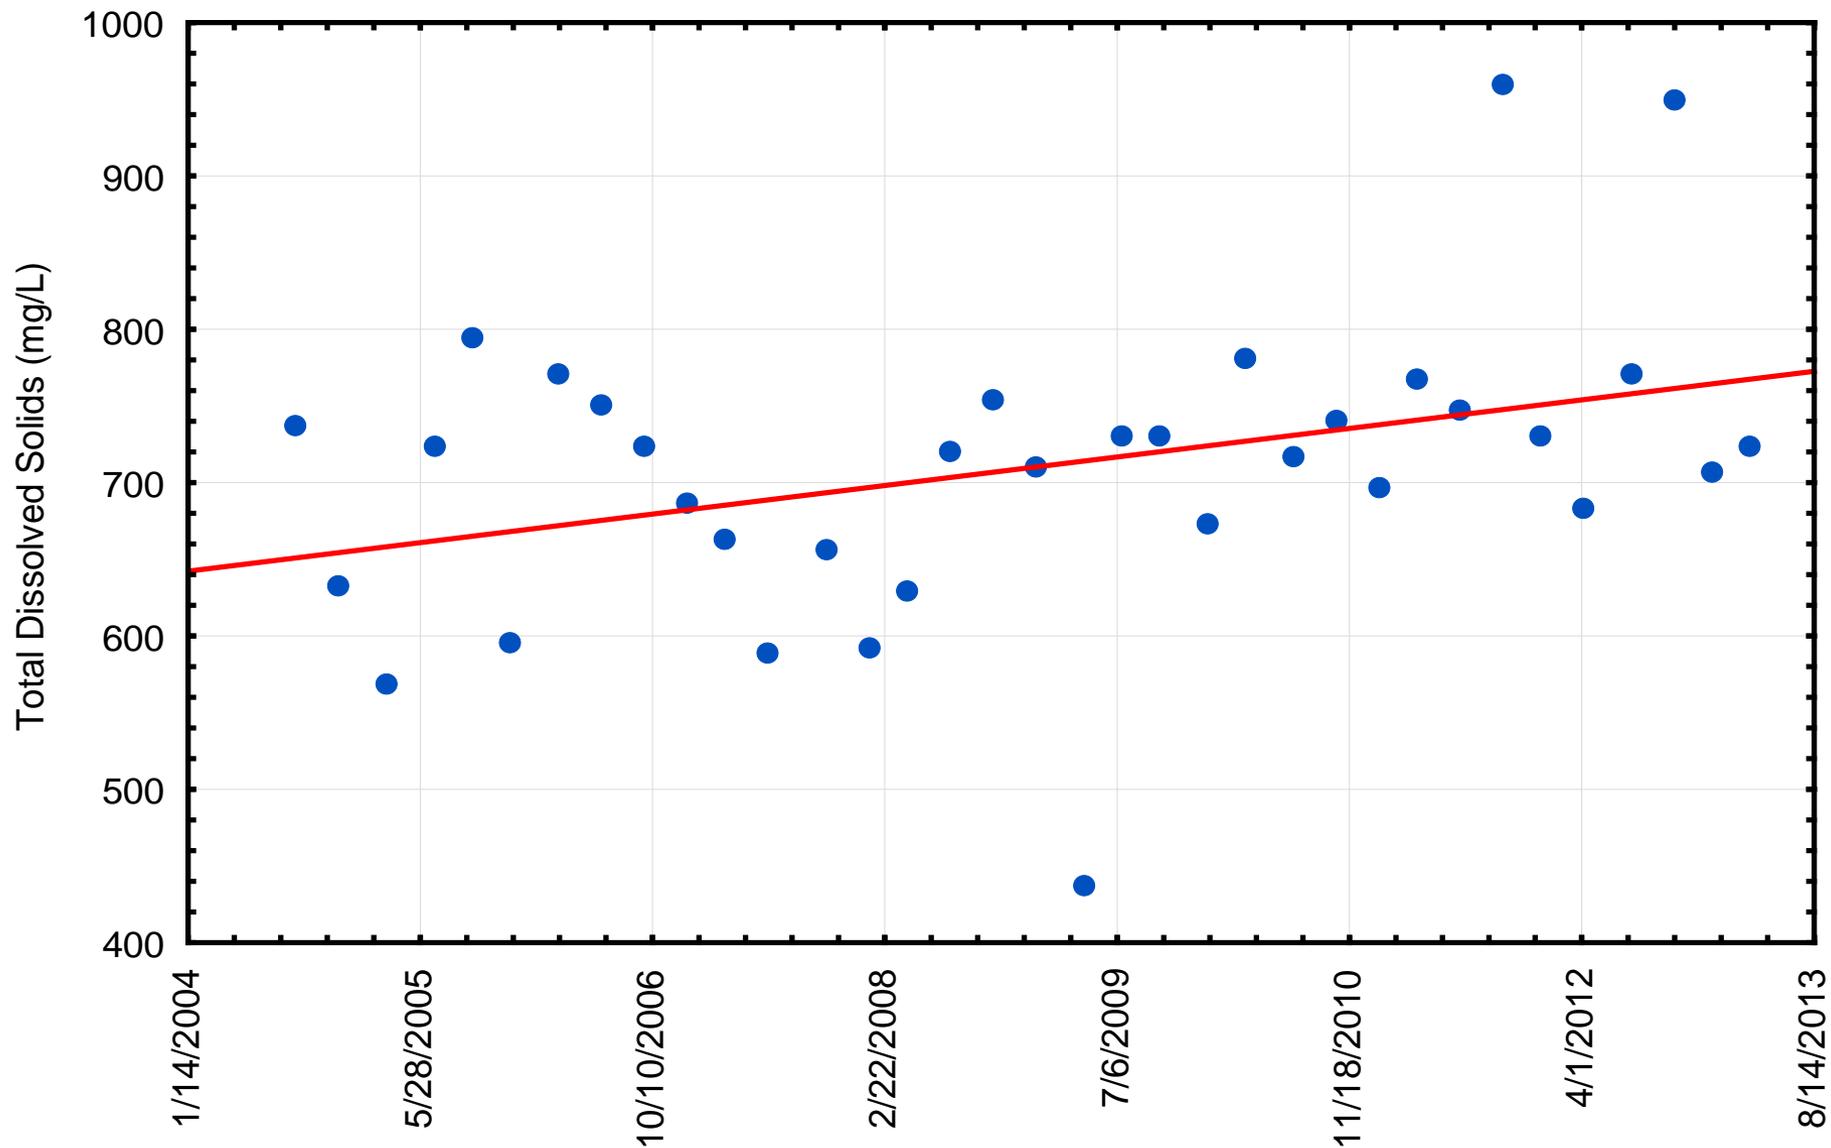
McClellan Creek  
Segment 0224A\_01  
Total Dissolved Solids (TDS)

- Salt Fork of the Red River (0222)
- McClellan Creek (0224A)
  - **Bacteria impairment**
  - **No concerns**
- Sweetwater Creek (0299A)
