CANADIAN RIVER BASIN

FACTORS INFLUENCING WATER QUALITY

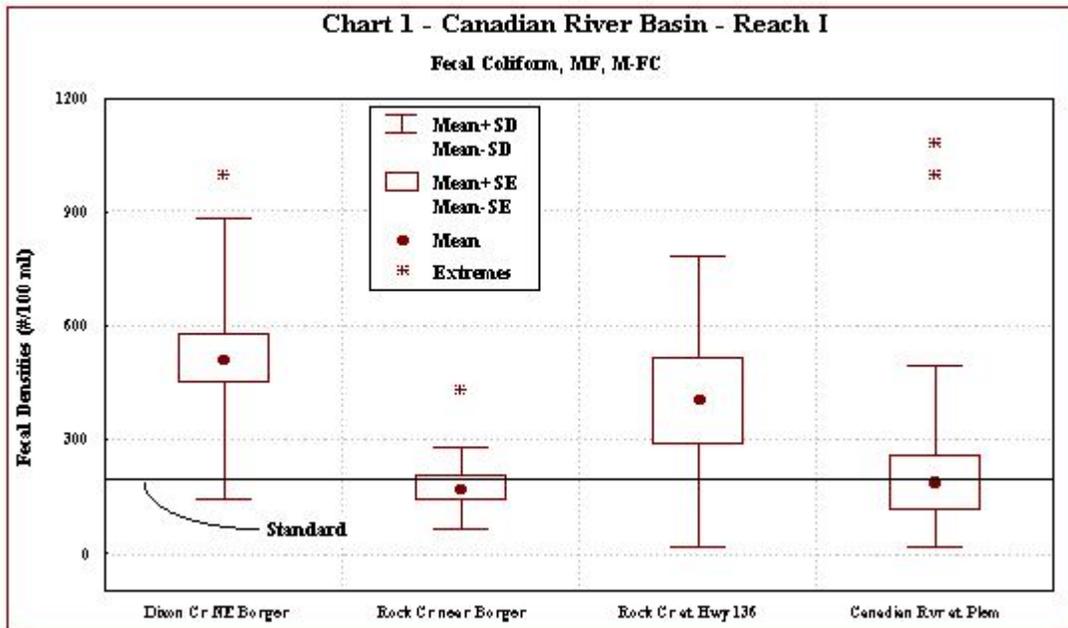
Chart 1 depicts the fecal coliform densities observed in Rock Creek, Dixon Creek and the Canadian River in Hutchinson County. The group of box plots indicate the overall range of the values reported for each station over the last five years.

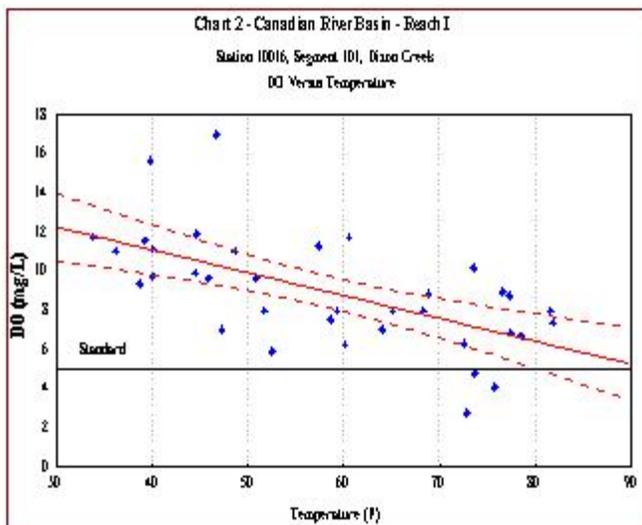
Chart 2 depicts the correlation between dissolved oxygen and temperature over time for station 10016 at Dixon Creek. Dixon Creek is included on the CWA §303(d) list for low DO. Note that only three values fall below the standard.

Dixon Creek at station 10016 reported one fish kill in 1998, cause unknown. This could have contributed to the low DO possibly due to decaying aquatic life. In July 2000, another low DO and elevated levels of fecal coliform were observed immediately following a flood event. The elevated levels of fecal coliform following a flood event is a common occurrence considering the agribusiness activities in the area. The extremely high temperatures are believed to be the cause of the depressed dissolved oxygen levels, probably immediately prior to the flood event.

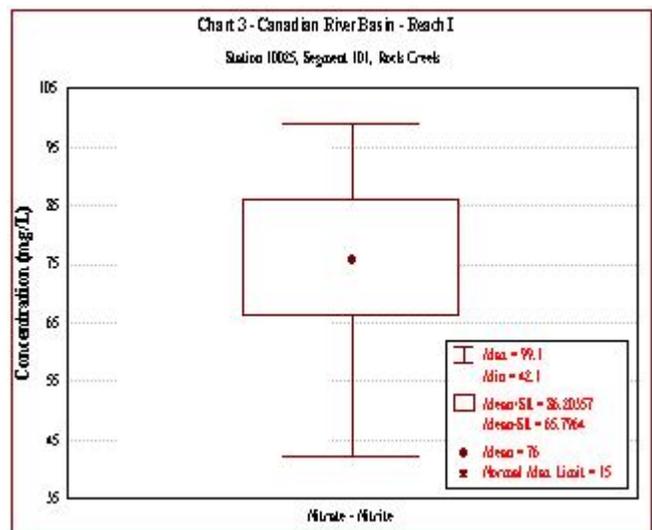
Chart 3 shows the abnormally high concentration of nitrate-nitrite observed during the latter part of the study period at station 10025 in Rock Creek near Borger, Texas. The elevated levels appear to be originating from an industrial manufacturing plant upstream of the monitoring stations. Further monitoring has been scheduled to identify the actual source of contamination and/or validate this assumption.

The Rock Creek monitoring station (10025) has experienced several elevated levels of nitrate-nitrite. This station is located approximately one mile downstream of a nitrogen manufacturing plant near Borger in Hutchinson County. Although a direct correlation has not been established, monitoring will continue to accurately identify the cause of the increased levels.

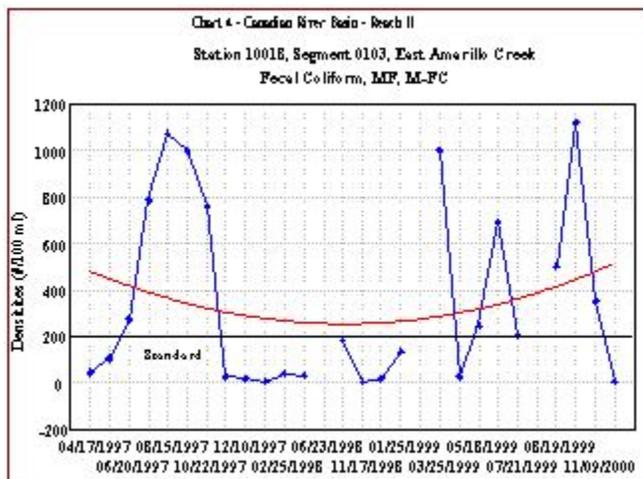
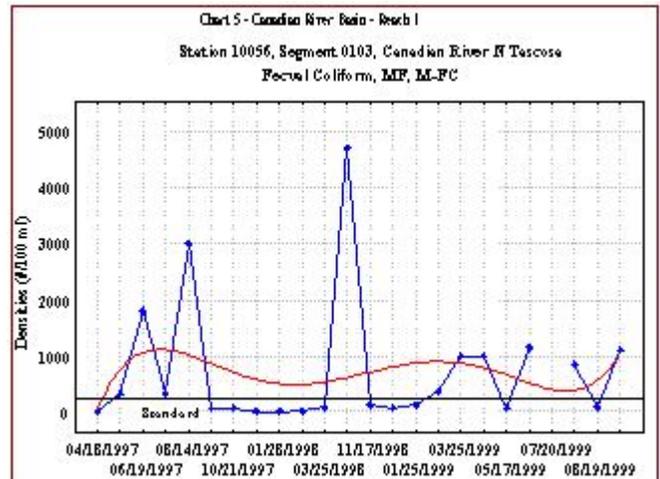
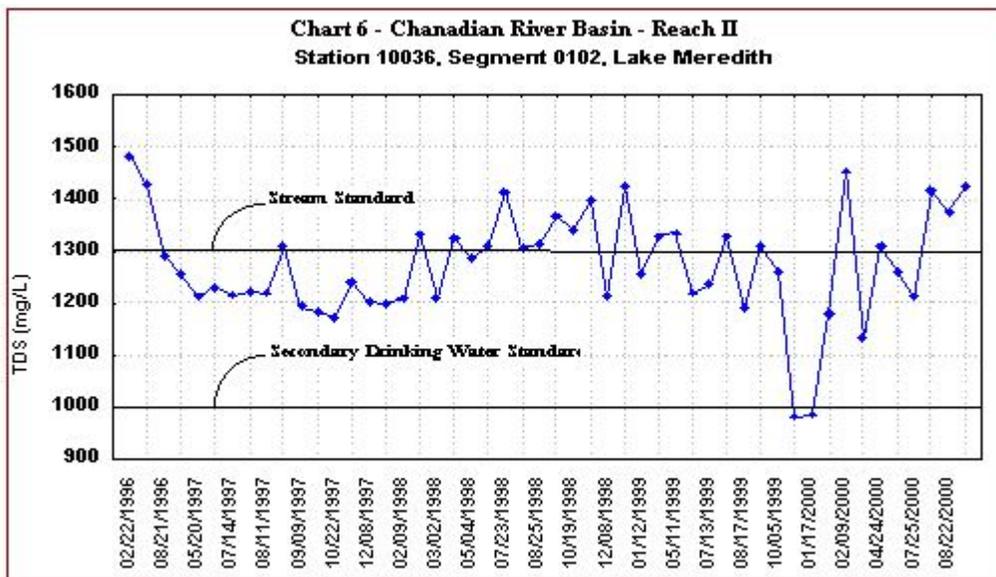
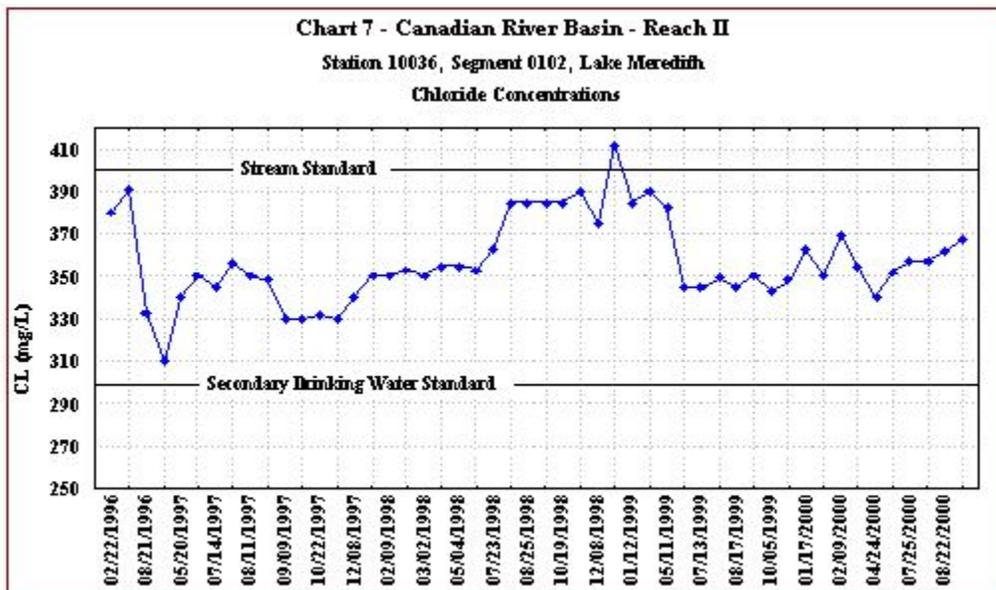
Station 10018 at East Amarillo Creek just north of Amarillo in segment 0103 and station 10056 on the Canadian River bridge north of Tascosa in segment 0103 both reported elevated levels of fecal coliform bacteria. These exceedances appear to be the result of storm water runoff of ranching and/or cattle raising activities. Livestock have access to both station locations and utilize the stream for watering. **Charts 4** and **5** depict the fecal coliform densities over time for each station. Other conventional parameters appeared to be within normal limits for this region.

Segment 0102 (Lake Meredith) is designated as a water supply, however, the current water quality does not meet secondary drinking water standards, which is the segment's primary use. According to the TNRCC's screening procedures for surface water quality standards, TDS and chloride levels did not exceed the standards set for Lake Meredith. However, it should be noted that the mean TDS levels often are very near the standard of 1,300 mg/L and have a tendency to exceed the standard during summer months or low lake levels. The TDS values show a direct correlation between lower lake levels and higher TDS concentrations. Dissolved solids, namely chlorides, continue to pose a major water quality issue in this segment due to the primary uses of the surface water impounded in Lake Meredith. **Charts 6** and **7** show a comparison between the surface water quality standard and drinking water standard for TDS and chloride levels over the period of record.

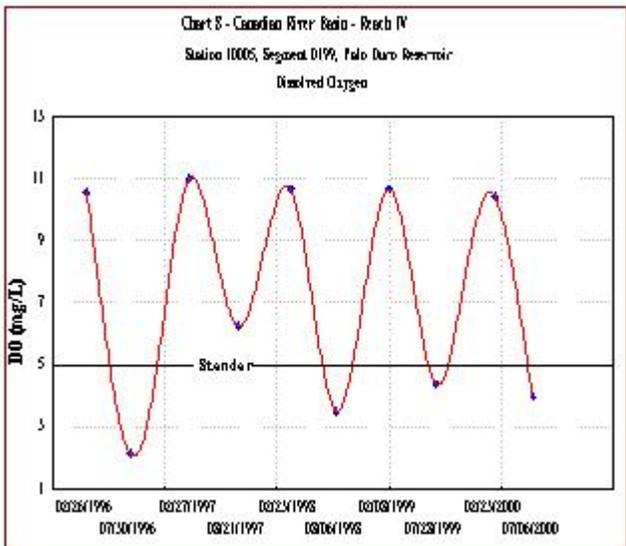
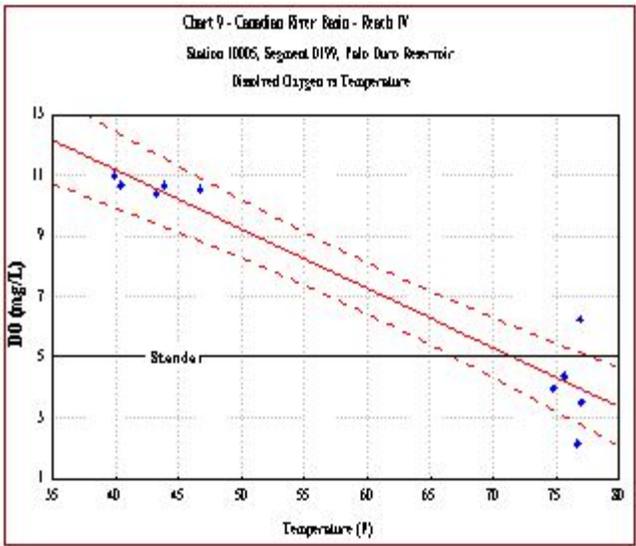
One routine quality monitoring station provided data for screening in this reach, station 10005 (Palo Duro Reservoir). Palo Duro Reservoir is on the §303(d) list for occasional low dissolved oxygen (DO) levels, but only ten samples were collected over the period. **Charts 8 and 9** show that the DO swings correlate directly with seasonal changes and the warmer summer months resulting from naturally occurring conditions. All other conventional parameters appear to be within normal ranges for the region.

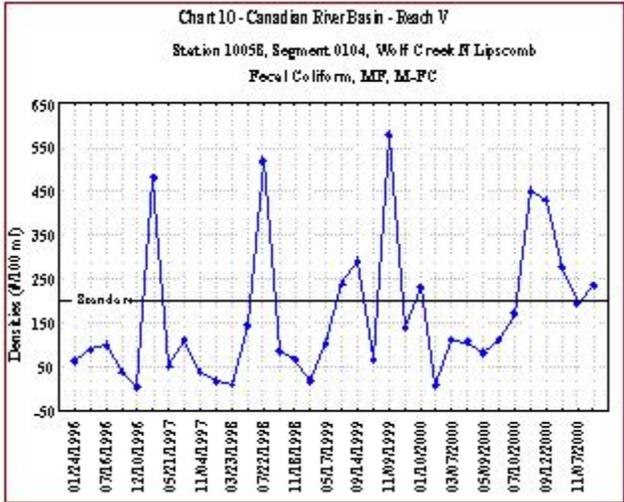
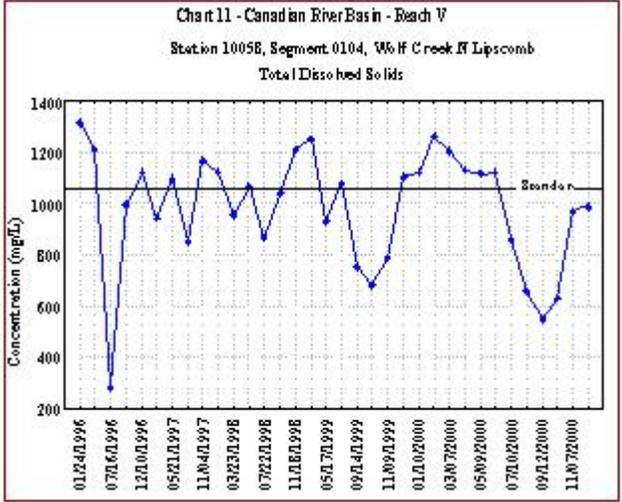
Of the constituents screened, fecal coliform was identified as the only parameter exceeding the screening criteria at station 10058 (Wolf Creek). Elevated levels of fecal and TDS appear to be the result of runoff of agricultural areas. Refer to **Charts 10** and **11** for details. Livestock have unlimited access to Wolf Creek and utilize it as a watering source. Only the occasional spike fecal levels correlated with runoff of pasture lands following a rainfall event. The other conventional parameters appeared to be within normal ranges for the region.
