2016 BASIN HIGHLIGHTS REPORT

AN OVERVIEW OF WATER QUALITY THROUGHOUT THE
CANADIAN AND RED RIVER BASINS

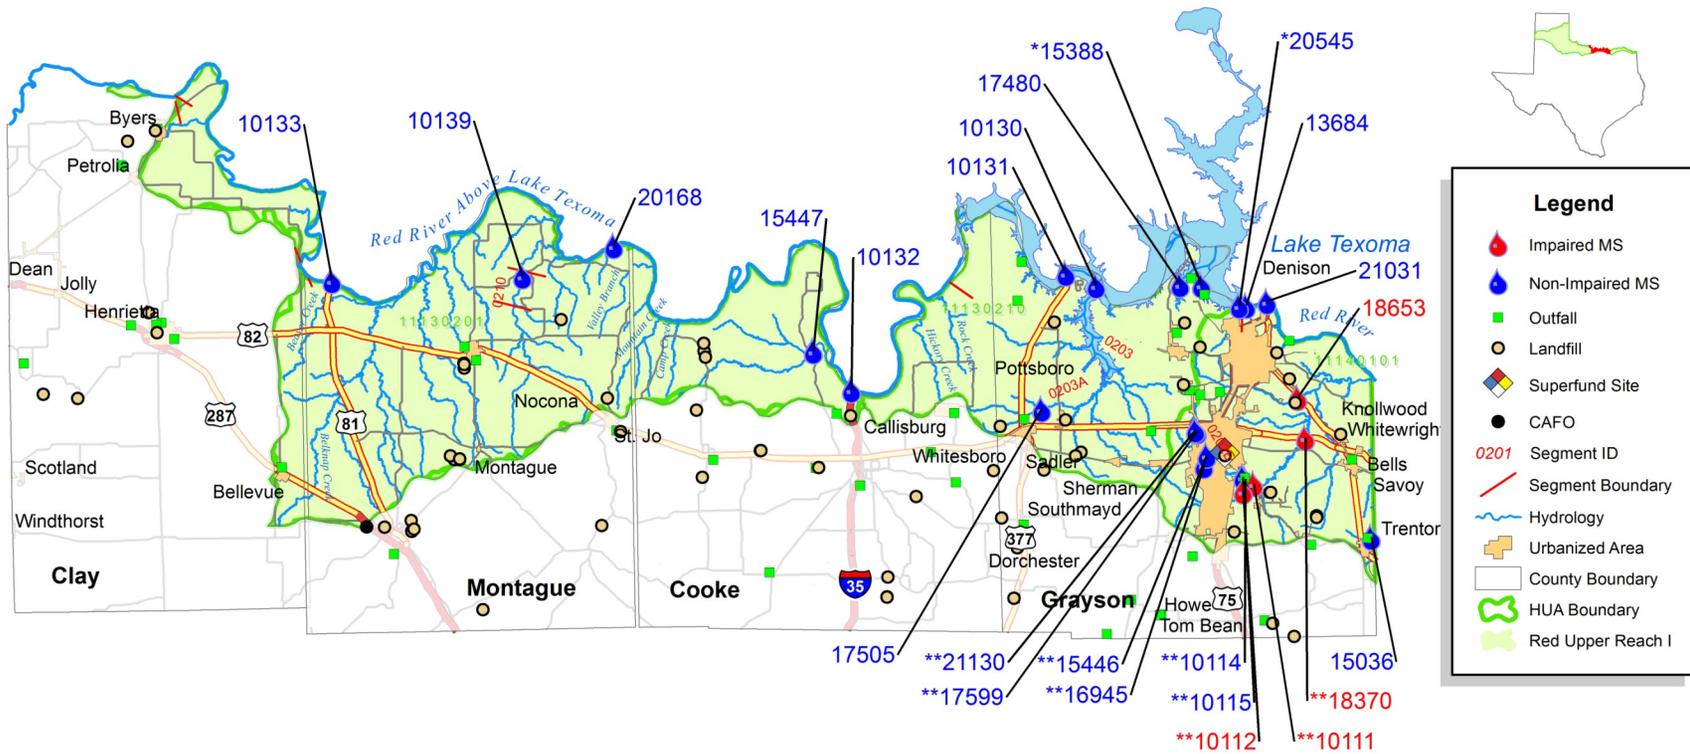
Red River Basin Upper Reach I

* Denotes site monitored by North Texas Municipal Water District.

** Denotes site monitored by City of Sherman.
